# Inventory & Check In

**WILSON**  
INVENTORIES

Example  
Inventory  
Report

**October**  
**24th 2025**  
09:30

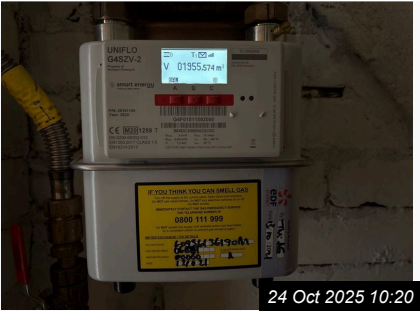
Ref #3.1

3. METRE READINGS			
Ref	Name	Description	Reading
3.1	Gas Meter	Location: Storage room, hallway Serial Number:G4F01511592000	01955 m3
3.2	Electric Meter	Floor: N/A Location: unable to locate	N/A

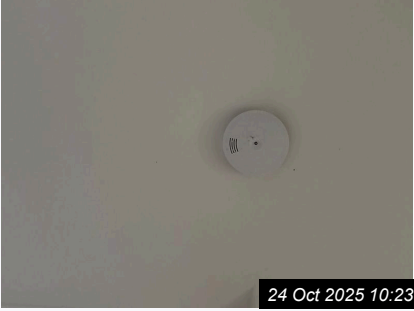
<div>24 Oct 2025 10:23</div><div>Ref #5.1</div></div><div>

5. SMOKE AND CO2 ALARMS			
Ref	Name	Location Room & Floor	Test Result
5.1	Smoke Alarms	Floor: 1 level Location: hallway	Sound heard
5.2	Carbon Monoxide Alarms	Floor: 1 level Location: Kitchen	Sound heard
<div><div>

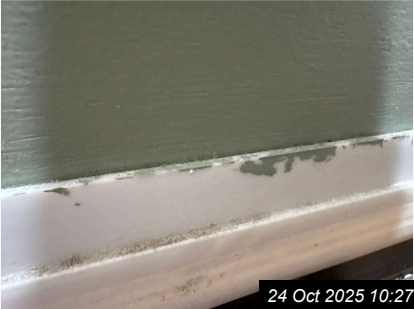
<div>24 Oct 2025 10:27</div><div>Ref #6.1</div></div><div>

Ref	Name	Description	Condition
6.1	Door & Frame	Painted wooden door and frame in white	Multiple scuffs marks and discolouration patches visible minor paint deterioration and accumulated dirt around frame edges.

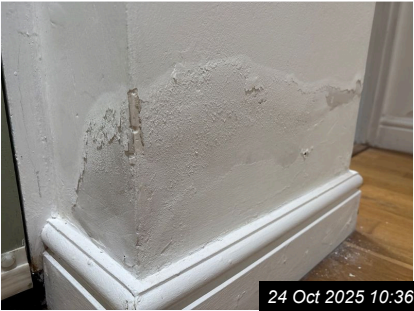
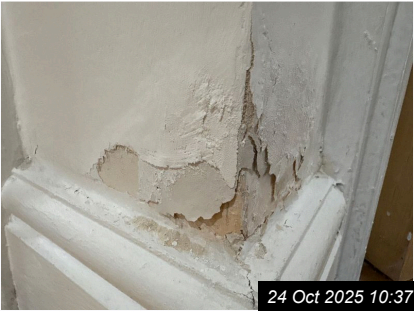
Ref #6.5

6.5	Walls	Painted plaster walls in white	Visible cracking near door frame Minor surface abrasions and marks present Patches of flaking paint and plaster Areas of damaged and missing plaster at lower levels

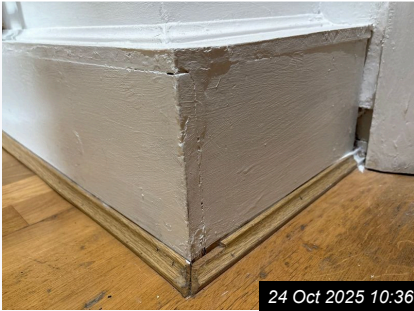
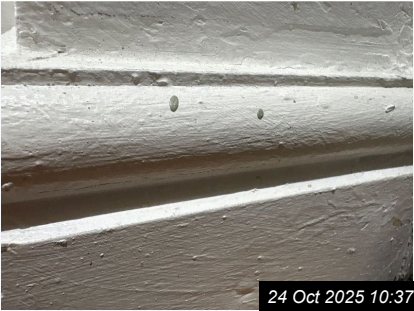
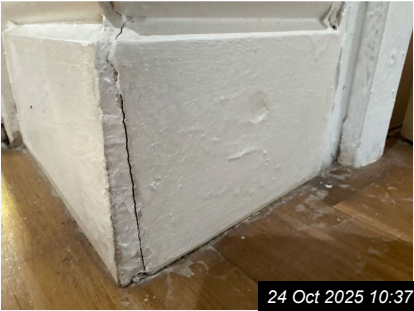
Ref #6.6

6.6	Skirting	Painted timber skirting in off-white	Shows visible cracks, chipped paint, uneven finish, and some scuffing and wear along lower edges.
6.7	Switch / Sockets	Single metallic light switch with a brushed silver finish	Switch plate shows light surface marks and minor smudges, otherwise intact with no visible damage.

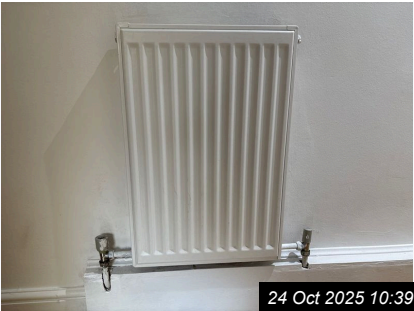
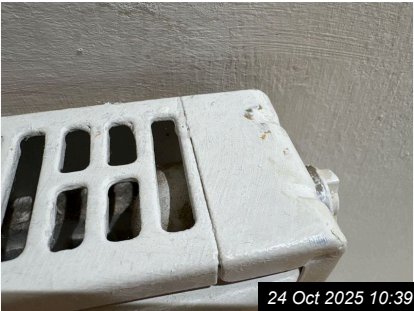
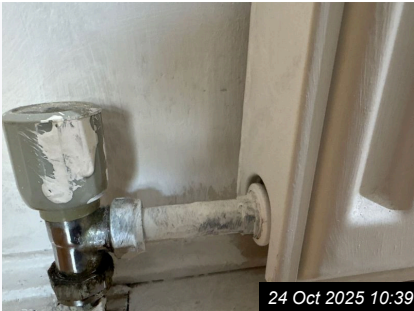
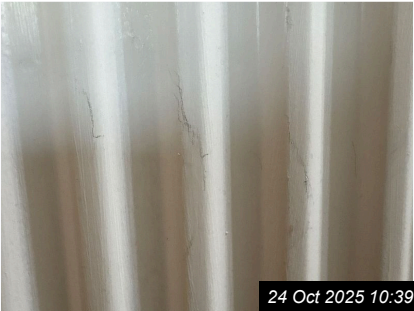
Ref #6.8

6.8	Heating	Wall-mounted white metal radiator with painted pipework.	Multiple scuffs abrasions and chipped paint visible with paint residue on valve and rust spots at corners.

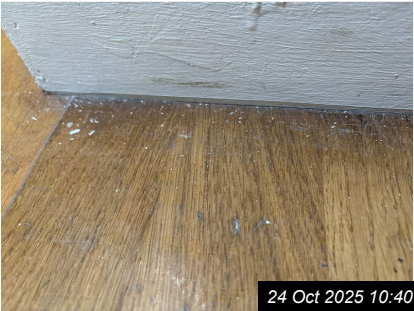
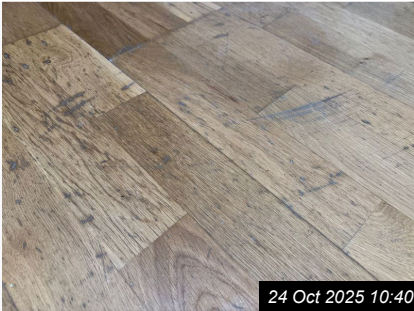
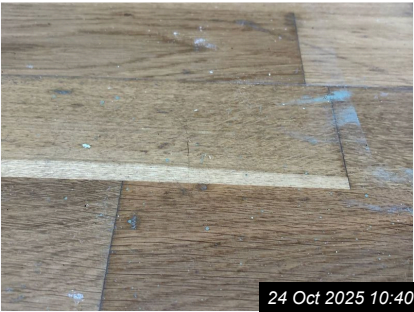
Ref #6.9

6. ENTRANCE & HALLWAY (CONT.)			
6.9	Flooring	Wood parquet flooring in a medium brown shade with a natural grain pattern	Flooring shows scratches, scuff marks, and scattered paint spots, with visible signs of wear.
Contents

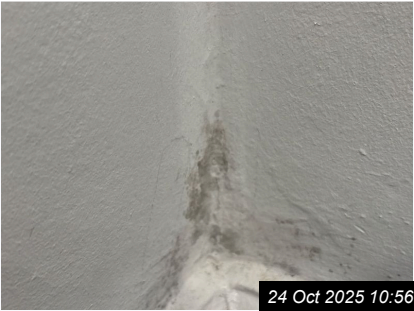
<div>24 Oct 2025 10:56</div> <div>Ref #8.5</div>

8.5	Walls	Emulsion painted plaster walls in off-white	Walls show multiple cracks, scattered stains, minor paint marks, damp patches, screw holes, and general signs of wear.

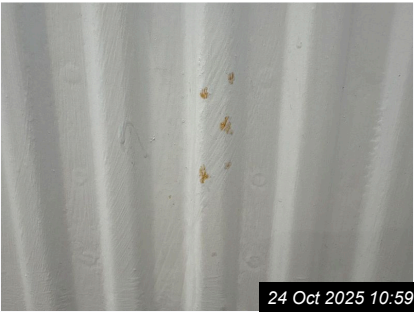
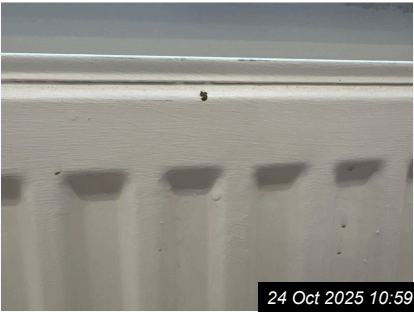
<div>24 Oct 2025 10:59</div> <div>Ref #8.10</div>

8.10	Heating	White metal painted radiator, connected to the central heating system.	Radiator shows multiple chips and areas of rust, as well as minor surface marks and stains.

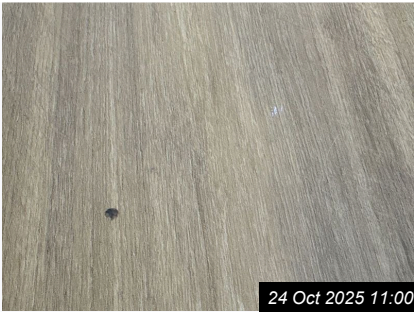
<div>24 Oct 2025 11:00</div> <div>Ref #8.11</div>

8.11	Flooring	Wood effect vinyl flooring in a medium brown tone	Visible marks and minor stains present with some scratches and light surface damage.
8.12	Kitchen Units	Gloss cream coloured kitchen units with flat panel doors, integrated handles and laminate worktops.	Units show signs of wear with visible scuffing, staining, chipped edges, minor surface marks and some internal discolouration.

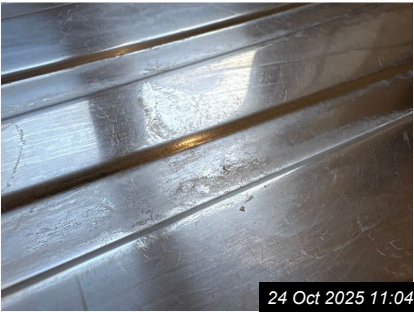
<div>24 Oct 2025 11:04</div> <div>Ref #8.14</div>

8.14	Sink	Stainless steel single-bowl sink with attached drainer and chrome dual-handle mixer tap.	Sink shows visible surface scratches and worn areas on drainer Limescale and grime around waste and overflow No major dents or structural damage
Appliances

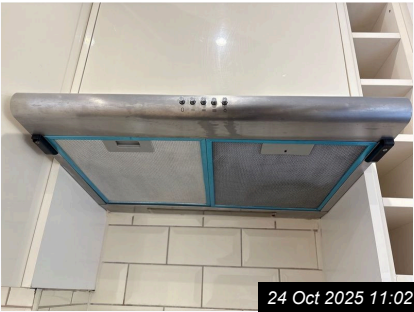
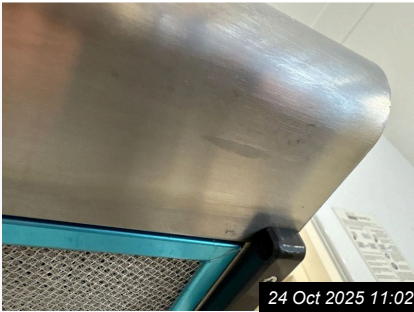
<div>24 Oct 2025 11:02</div> <div>Ref #8.15</div>

8.15	Extractor Hood	Stainless steel extractor hood with control buttons and twin mesh filters; Blue filter frames and black plastic side brackets.	Visible signs of rust and dirt on mesh, cracked plastic bracket, scratched housing and worn areas around fixings.

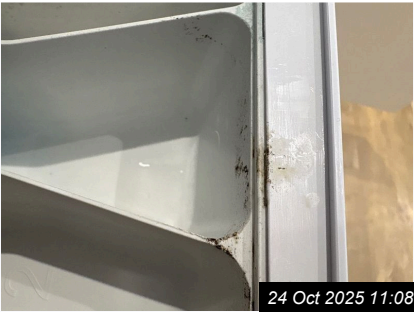
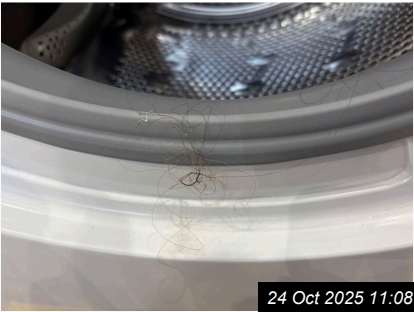
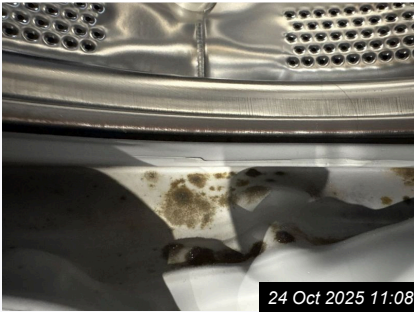
<p>24 Oct 2025 11:08</p>
Ref #8.19	Ref #8.19	Ref #8.19

8.19	Washing Machine	White front-loading Baumatic washing machine with digital display and multiple wash settings located in the kitchen.	Visible residue and mould present in the detergent drawer and door seal, hair on door seal, internal seal shows notable areas of dirt and mould. <a href="#">Review - Investigate</a>

Actions Required			
Ref	Action Required	Responsibility	Comments
<a href="#">8.19</a> KITCHEN » Washing Machine	Review	Investigate	Visible residue and mould present in the detergent drawer and door seal, hair on door seal, internal seal shows notable areas of dirt and mould.;

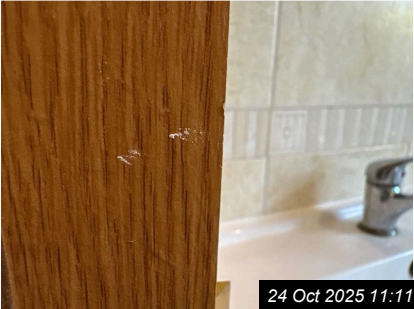
<div>24 Oct 2025 11:11</div><div>Ref #9.1</div></div><div>

Ref	Name	Description	Condition
9.1	Door & Frame	Wood-effect door with matching frame, golden brown finish, door frame painted white.	Door and frame show multiple areas of minor scratches, chips on edges, paintwork damage, and surface scuffs.

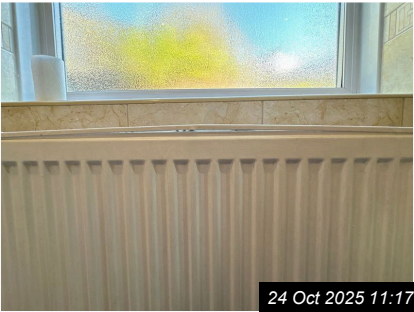
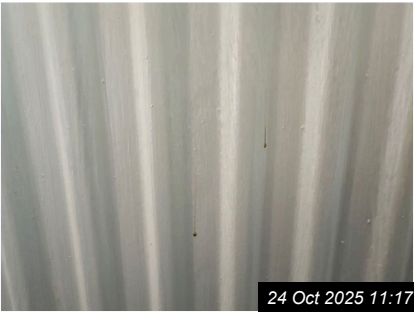
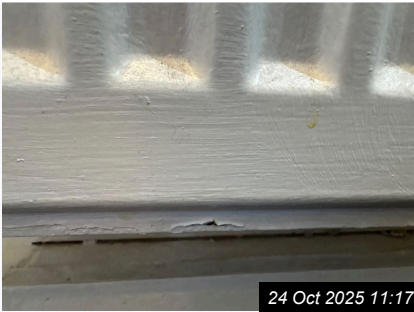
<p>24 Oct 2025 11:17</p> <p>Ref #9.9</p>

9.8	Switch / Sockets	White ceiling-mounted pull cord switch	Switch and cord appear intact with no visible damage or discolouration.
9.9	Heating	White metal panel radiator and chrome ladder-style heated towel rail	Radiator has minor paint chips, some small rust spots and wear on the lower edge. Towel rail exhibits visible rust patches around joints and general surface wear.

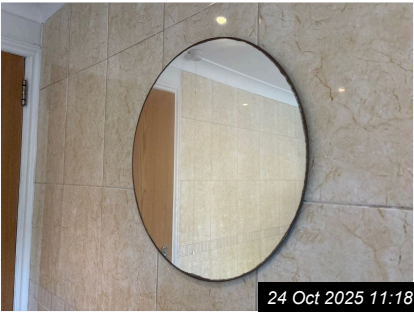
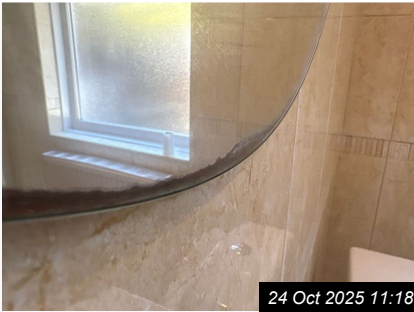
<p>24 Oct 2025 11:18</p> <p>Ref #9.14</p>

9.14	Mirror	Oval shaped, mounted to wall, frameless	Silvering to mirror edges
Cleanliness			
9.15	Cleanliness	Professional clean	
<div><div>

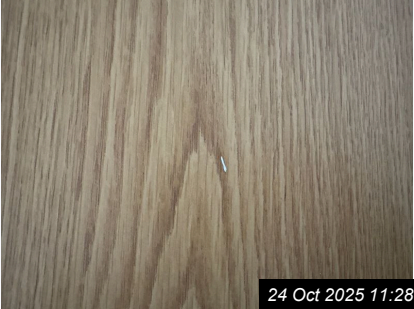
<div>24 Oct 2025 11:28</div><div>Ref #10.1</div></div><div>

Ref	Name	Description	Condition
10.1	Door & Frame	Light oak veneer door with matching wooden frame.	Multiple scratches and scuff marks present on the door Chipped paint and damage on the frame, small dent visible on door surface.

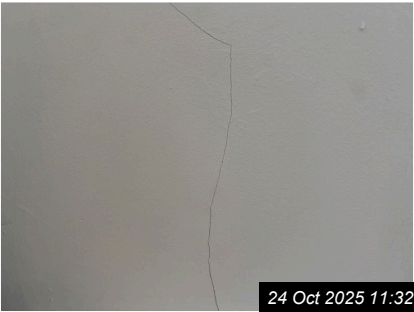
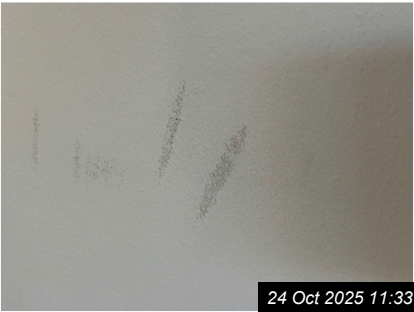
<p>24 Oct 2025 11:32</p> <p>Ref #10.5</p>

10.5	Walls	Painted plaster walls in light off-white colour	Multiple areas of peeling paint, visible cracks, scuff marks, and patches of damp or staining evident at lower sections and corners.

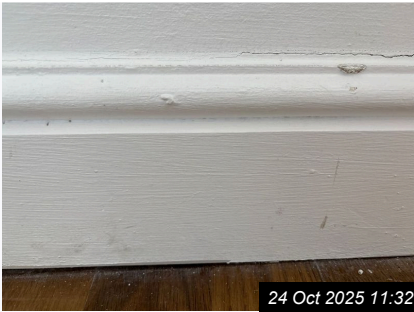
<p>24 Oct 2025 11:32</p> <p>Ref #10.6</p>

10.6	Skirting	White painted timber skirting	Multiple dents, chips, cracks, paint bubbles, surface marks, and poorly executed repair patch visible.
