# Inventory & Check In

**WILSON**  
INVENTORIES

Example  
Inventory  
Report

**October**  
**25th 2025**  
10:00

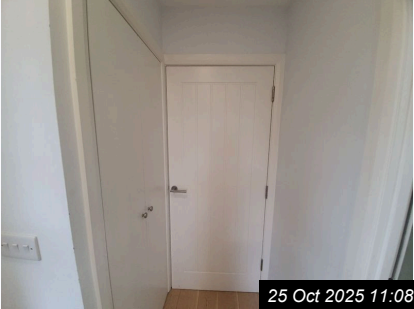
<div>25 Oct 2025 11:08</div><div>Ref #7.1</div></div><div>

Ref	Name	Description	Condition
7.1	Door & Frame	White painted wooden door and frame	Several black scuff marks and minor scratches are present on the door and frame near the latch area.

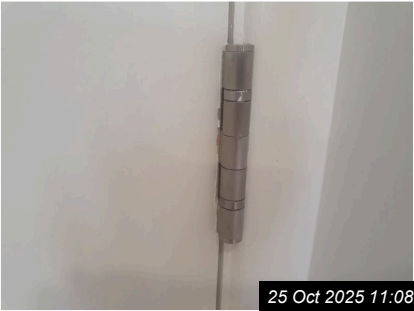
<p>25 Oct 2025 11:08</p> <p>Ref #7.2</p>

7.2	Door Fixtures	Brushed metal cylindrical lever handle Matching brushed metal door hinge	Handle is clean with minor paint transfer near base hinge has slight paint residue and minor scuffs.

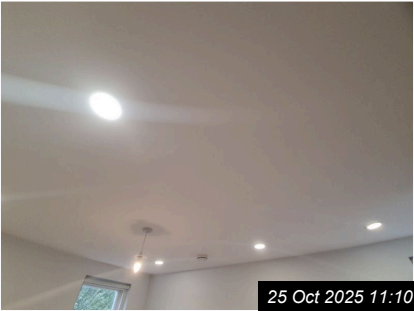
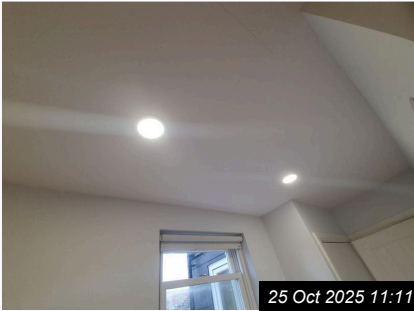
<p>25 Oct 2025 11:10</p> <p>Ref #7.3</p>

7.3	Ceiling	Smooth white plaster ceiling	Ceiling appears clean with no visible stains or damage, minor crack noted near the window corner.
7.4	Lighting	Ceiling fitted with four recessed LED downlights and one central pendant light with exposed bulb all in white housing.	All lighting fixtures appear intact with no visible damage or wear all bulbs functional.

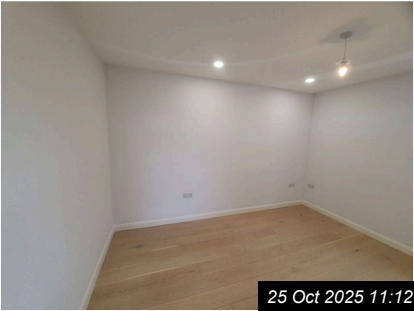
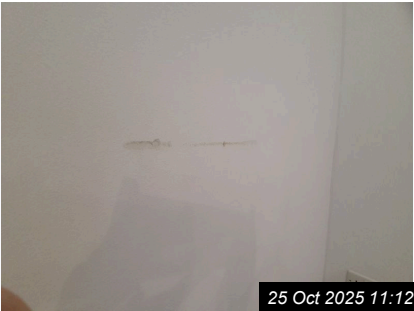
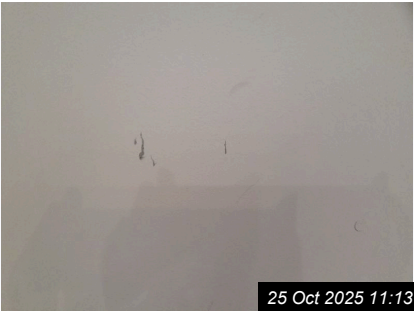
<p>25 Oct 2025 11:12</p> <p>Ref #7.5</p>

7.5	Walls	Plain painted plaster walls in light neutral colour	Several areas of scuff marks scratches and minor surface damage visible on multiple walls.

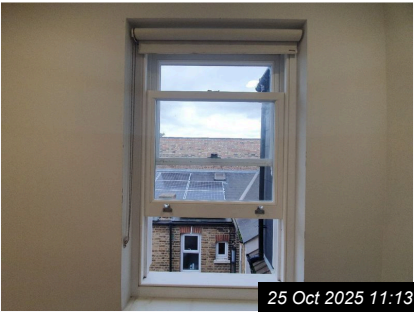
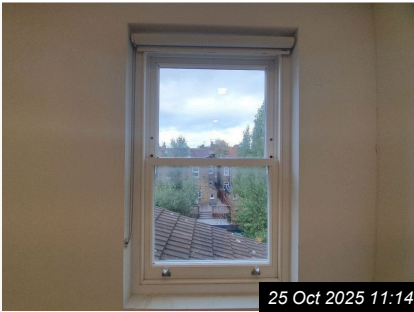
<p>25 Oct 2025 11:13</p> <p>Ref #7.7</p>

7. BEDROOM ONE (CONT.)			
7.7	Windows & Sills	White painted timber sash windows with metal latch hardware and matching timber sills.	Minor scuff marks and dirt present on sills, paint worn in areas, window locks appear functional.

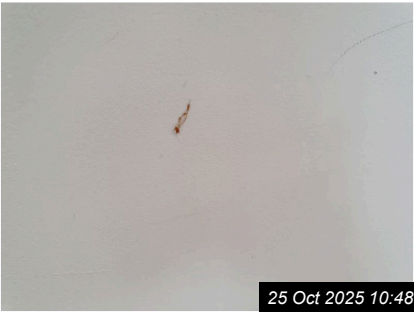
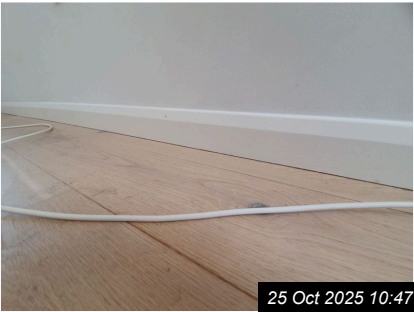
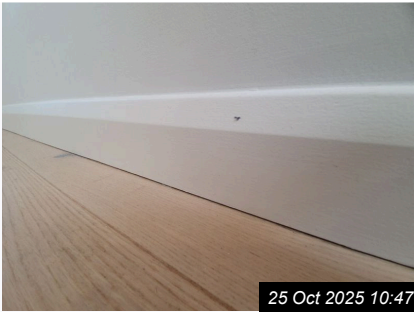
<div>25 Oct 2025 10:48</div> <div>Ref #8.5</div>

8.5	Walls	Walls are plastered, painted white	Walls display multiple scuff marks, scratches, paint chips, and minor surface damage.
8.6	Skirting	White painted wooden skirting board	Minor scuff marks and a small chip present, otherwise generally intact.

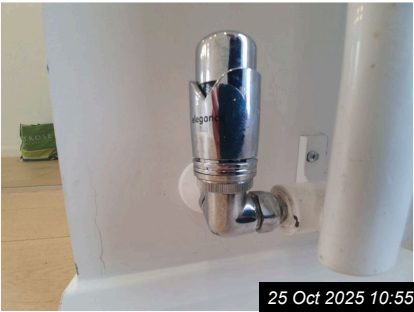
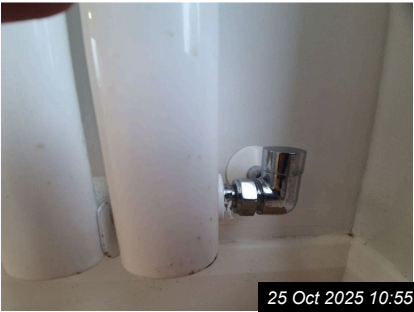
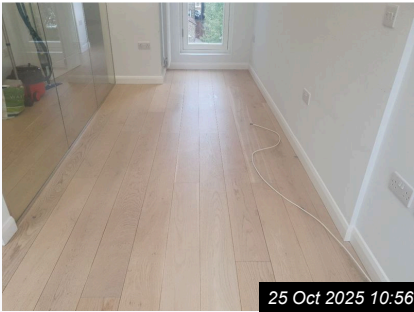
8.10	Heating	Vertical white tubular steel radiator with chrome thermostatic and manual valves	Radiator and valves show minor surface marks and light soiling on lower pipes, wall around the installation has visible hairline cracks.

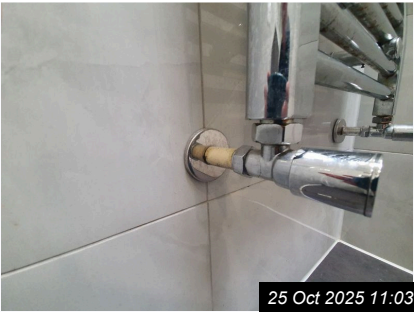
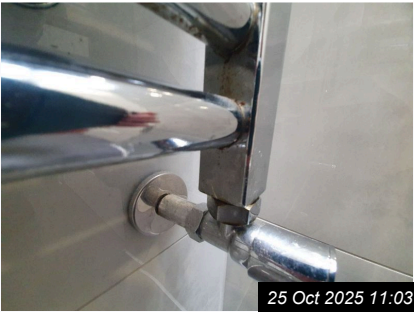
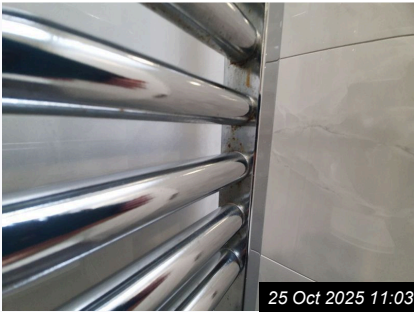
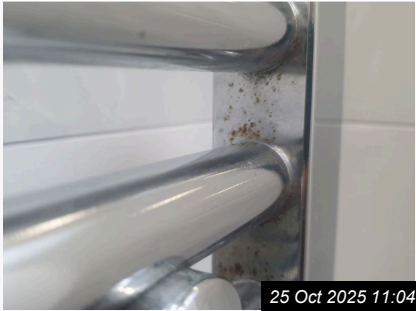
<div>25 Oct 2025 11:03</div> <div>Ref #9.9</div>

9.9	Heating	Chrome-finished wall-mounted towel rail radiator with multiple horizontal bars.	Multiple small rust patches and signs of corrosion present on joints and connecting bars, with some discolouration visible near pipe connections and mounting points.

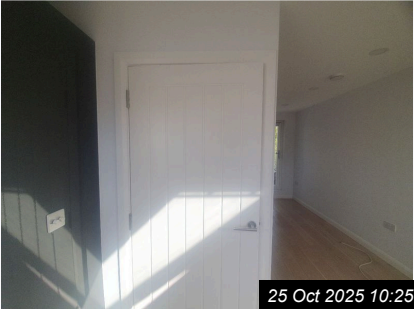
<div>25 Oct 2025 10:25</div><div>Ref #10.1</div></div><div>

Ref	Name	Description	Condition
10.1	Door & Frame	White painted timber door with vertical grooves and matching white frame	Door has visible scuff marks, scratches, and some dirt marks, especially on the lower section and edges; Frame is generally intact with minor surface marks.

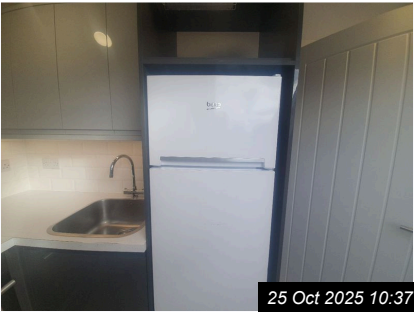
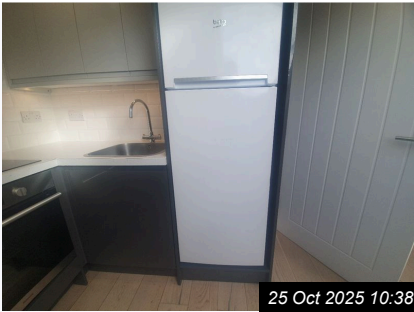
Ref #10.18

10.18	Fridge / Freezer	Freestanding white Beko fridge freezer with a top freezer compartment Matching metal handles, and multiple door storage racks and shelves inside.	Small areas of rust on the door, scuffs and marks to the outside, some internal shelf stains, and a cracked area near the bottom.
