# Inventory & Check In

**WILSON**  
INVENTORIES

Example  
Inventory  
Report

**October**  
**24th 2025**  
09:30

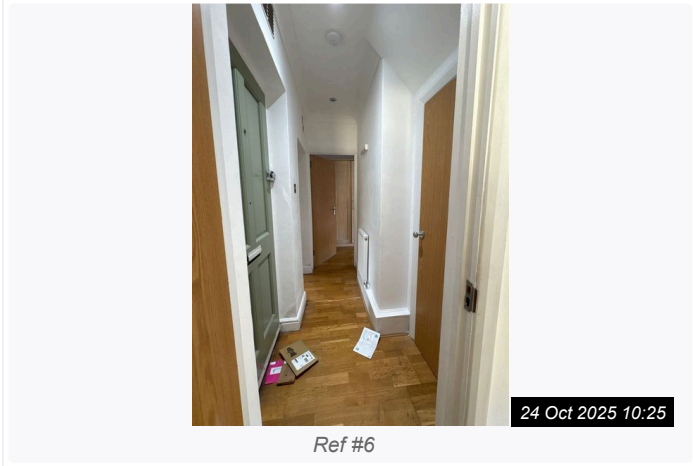
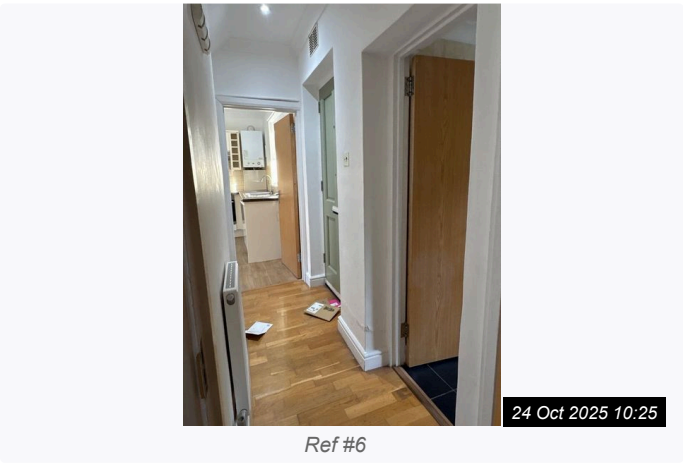
6. ENTRANCE & HALLWAY

Ref	Name	Description	Condition
6.1	Door & Frame	Painted wooden door and frame in white	Multiple scuffs marks and discolouration patches visible minor paint deterioration and accumulated dirt around frame edges.

6.5	Walls	Painted plaster walls in white	Visible cracking near door frame Minor surface abrasions and marks present Patches of flaking paint and plaster Areas of damaged and missing plaster at lower levels

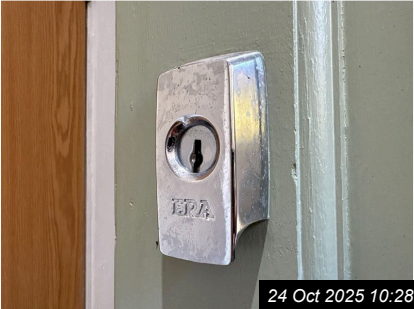
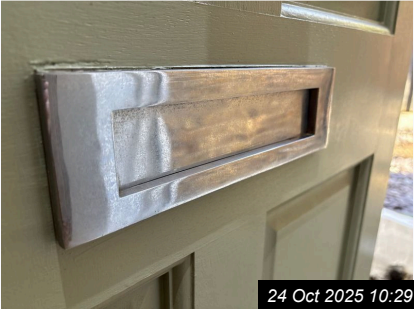
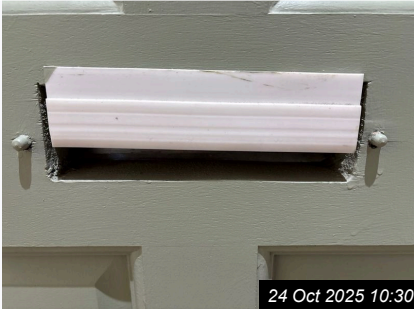
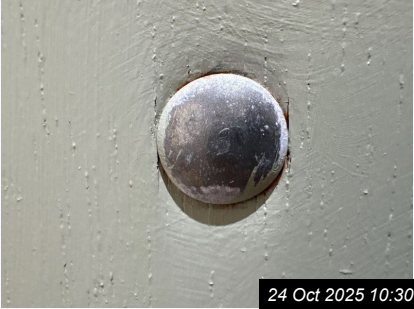
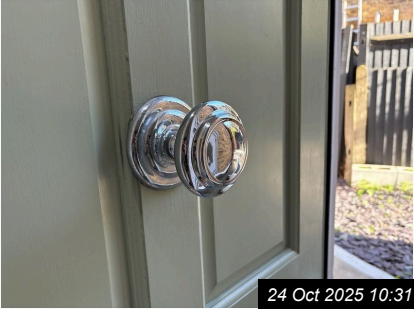
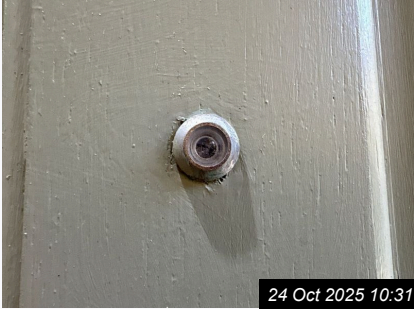
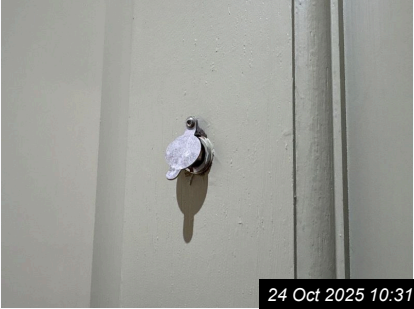
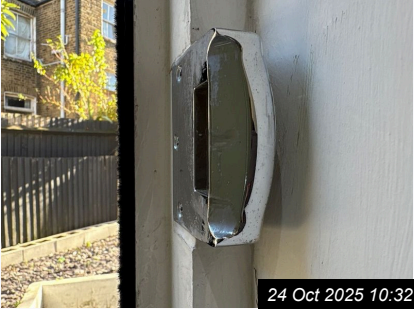
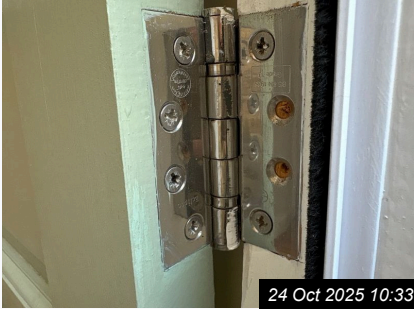
<div>24 Oct 2025 10:32</div><div>Ref #6.1</div></div><div>

6.2	Door Fixtures	Chrome key lock cover Chrome letter plate White internal letter flap Chrome security bolt cover Chrome door knob Chrome door viewer Chrome door viewer cover Chrome strike plate Chrome door hinge	Most fixtures have slight tarnish and scratches ; Minor paint wear to edges

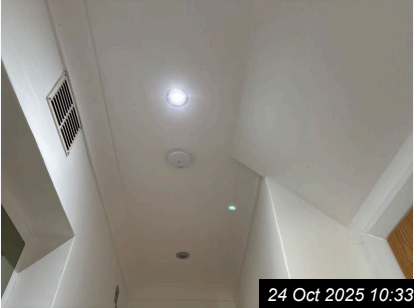
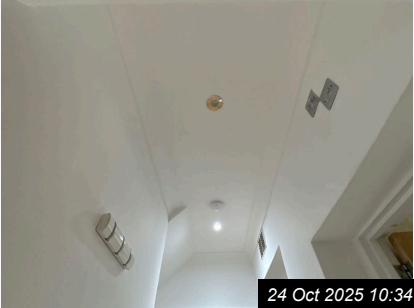
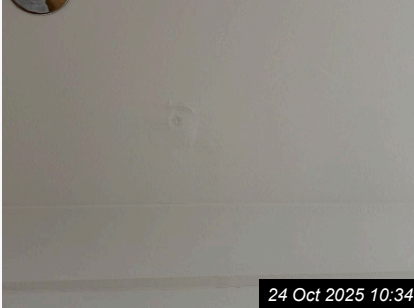
<p>24 Oct 2025 10:33</p> <p>Ref #6.3</p>

6.3	Ceiling	Ceiling is finished in white painted plaster	Ceiling shows a visible patch repair area and minor surface imperfections
6.4	Lighting	Ceiling-mounted recessed LED downlights with a metallic trim in a neutral finish.	All lights operational with no visible damage or signs of wear.

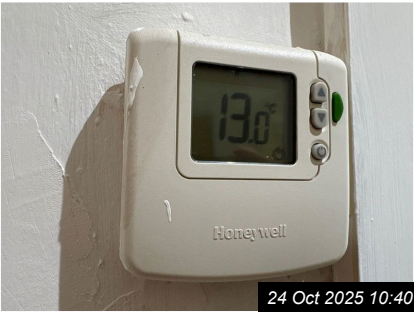
Ref #6.10

6.10	Thermostat	White, wall mounted	Appears in good condition
6.11	Pegs	White painted with chrome brushed pegs	Good condition
Cleanliness			
6.12	Cleanliness	Professional clean	
<div><div>

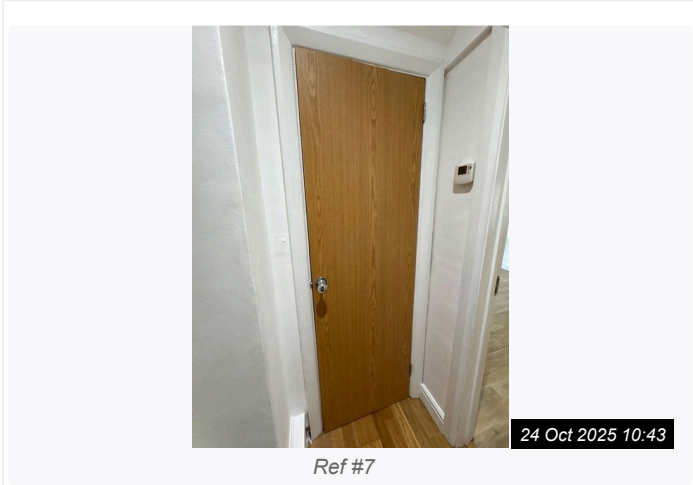
7. STORAGE ROOM

Ref	Name	Description	Condition
7.1	Door & Frame	Timber door with light brown wood grain finish and painted timber frame in white.	Door has a chip on the surface and worn edges; frame shows paint chips, dents, and exposed wood.

7.3	Ceiling	Painted timber beams with exposed structural detailing	Ceiling has visible cracks flaking paint and minor gaps at joints with one broken section towards the rear.

7.4	Walls	Painted brick walls in white with visible mortar joints	Walls show signs of cracking, chipped paint, uneven surfaces, and general wear.
7.5	Skirting	White painted timber	Skirting has scratches scuff marks paint chips and patches covering fixing holes.

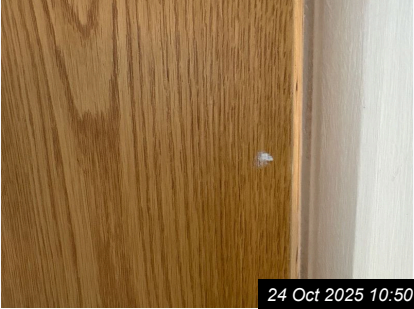
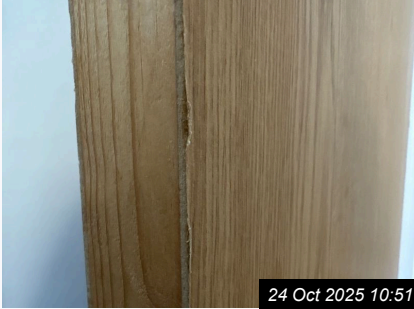
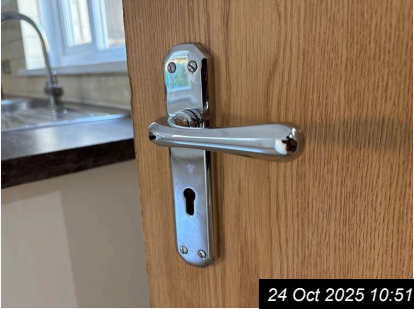
<div>24 Oct 2025 10:50</div><div>Ref #8.1</div></div><div>

Ref	Name	Description	Condition
8.1	Door & Frame	Light brown wood effect door and frame	Minor paint marks and scuffs visible with some edge wear noted on the frame.

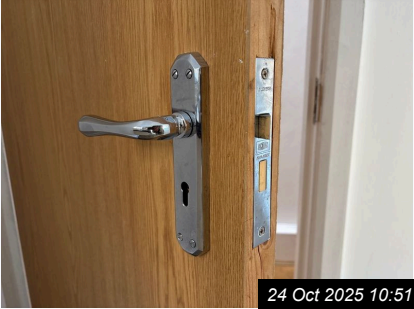
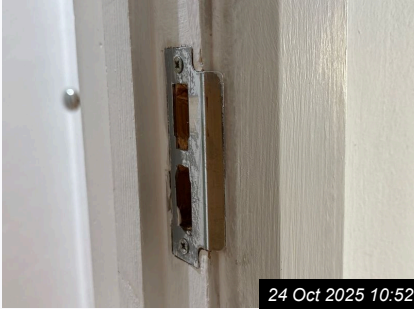
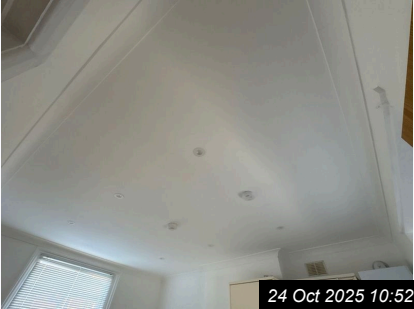
<div>24 Oct 2025 10:51</div><div>Ref #8.2</div></div><div>

8.2	Door Fixtures	Polished chrome lever handle on rectangular backplate with integrated keyhole; Matching chrome latch and strike plate	Handle and backplate are in good condition with minor surface marks; Latch plate and strike plate show signs of wear including scratches

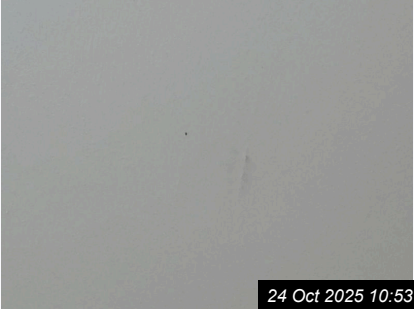
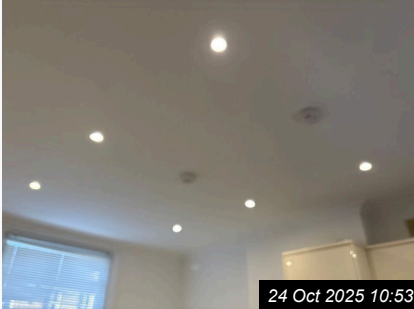
<div>24 Oct 2025 10:52</div><div>Ref #8.3</div></div><div>

8.3	Ceiling	Smooth white plaster ceiling	Minor mark and small indentation visible on the surface, otherwise appears sound.
8.4	Lighting	Recessed ceiling spotlights with a white trim	All lights appear functional with no visible damage or signs of wear.

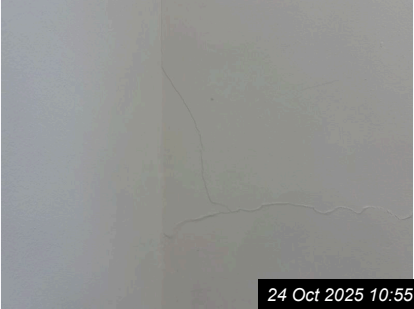
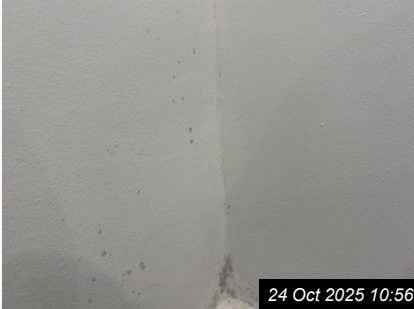
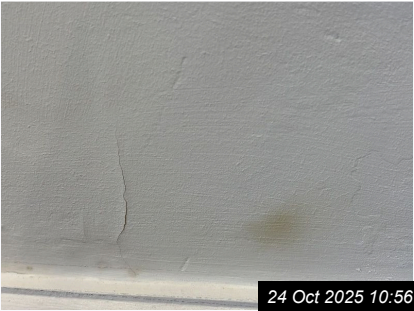
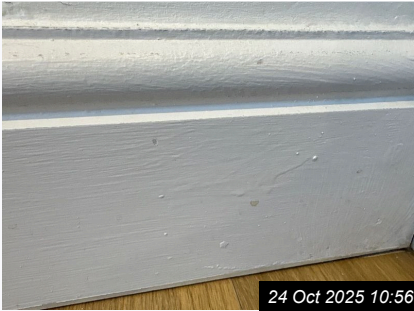
<div>24 Oct 2025 10:55</div><div>Ref #8.5</div></div><div>

8.5	Walls	Emulsion painted plaster walls in off-white	Walls show multiple cracks, scattered stains, minor paint marks, damp patches, screw holes, and general signs of wear.

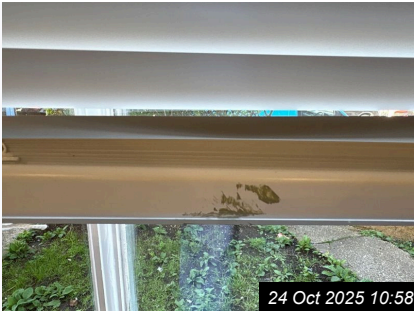
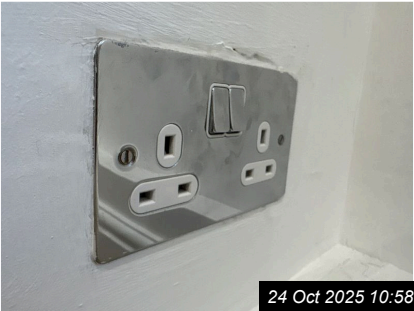
<div>24 Oct 2025 10:58</div> <div>Ref #8.8</div>

8. KITCHEN (CONT.)			
8.8	Blinds / Curtains	White horizontal venetian blinds made of metal with wand tilt and cord lift mechanism.	Some scuff marks and surface damage visible on the bottom rail, otherwise operational.

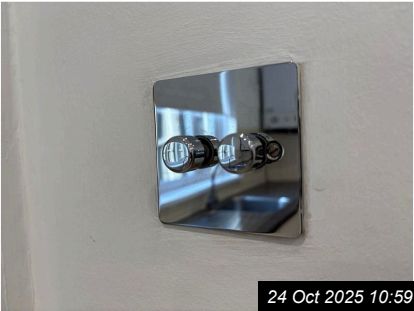
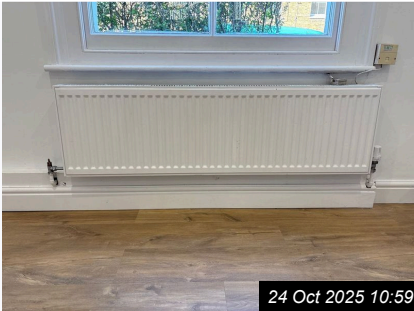
<div>24 Oct 2025 10:58</div> <div>Ref #8.9</div>

8.9	Switch / Sockets	Polished chrome double socket with two switches and polished chrome double dimmer switch	Socket shows minor surface marks and sign of uneven wall edges Dimmer switch is clean with no visible damage

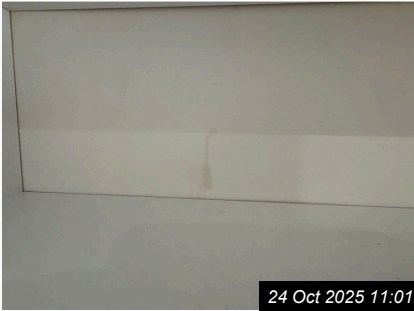
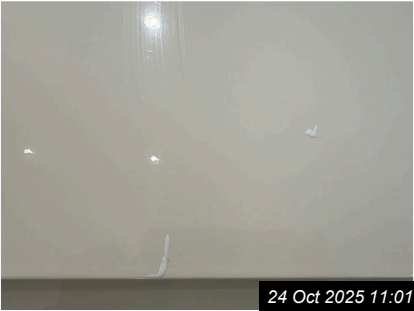
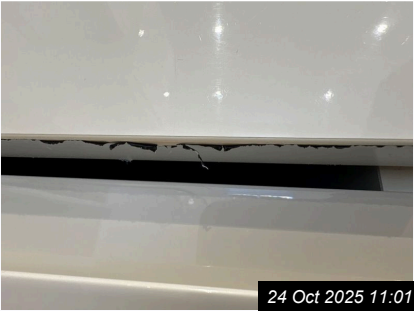
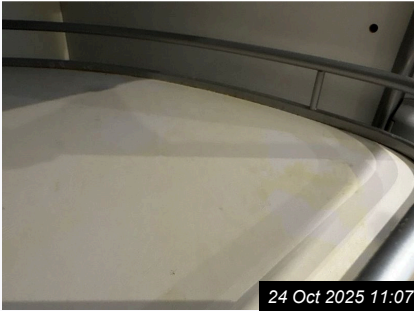
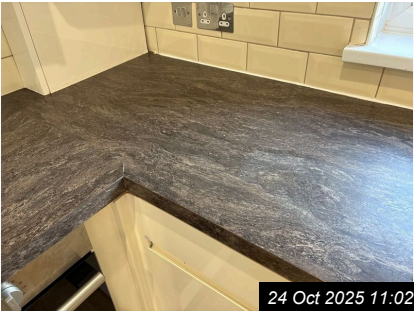
<div>24 Oct 2025 11:00</div> <div>Ref #8.12</div>

8.11	Flooring	Wood effect vinyl flooring in a medium brown tone	Visible marks and minor stains present with some scratches and light surface damage.
8.12	Kitchen Units	Gloss cream coloured kitchen units with flat panel doors, integrated handles and laminate worktops.	Units show signs of wear with visible scuffing, staining, chipped edges, minor surface marks and some internal discolouration.

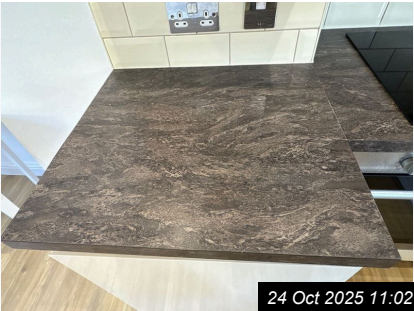
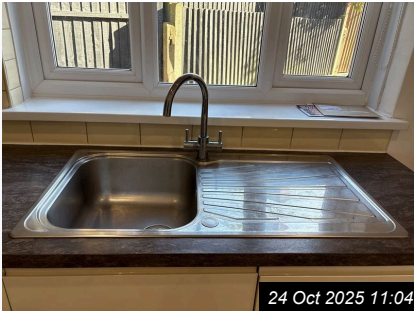
<div>24 Oct 2025 11:02</div> <div>Ref #8.13</div>

8.13	Worktops	Dark marbled laminate worktops with a matte finish	Worktops appear in good condition with no visible damage or significant signs of wear.

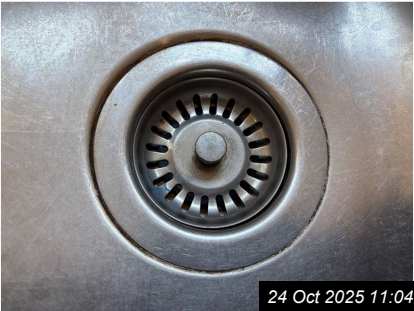
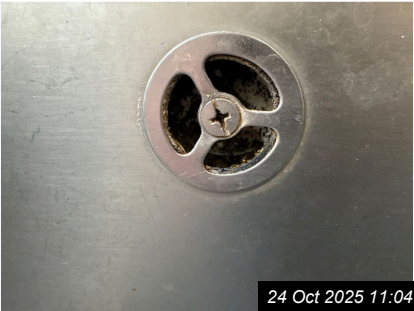
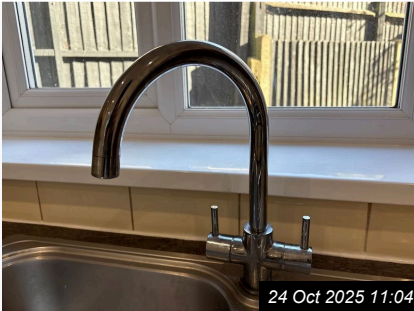
<div>24 Oct 2025 11:04</div> <div>Ref #8.14</div>

8.14	Sink	Stainless steel single-bowl sink with attached drainer and chrome dual-handle mixer tap.	Sink shows visible surface scratches and worn areas on drainer Limescale and grime around waste and overflow No major dents or structural damage
Appliances

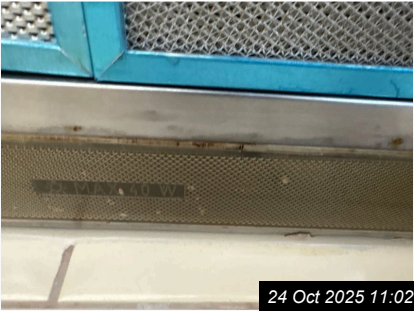
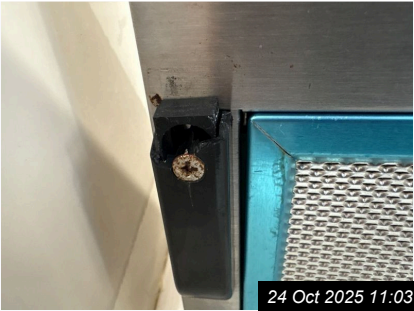
<div>24 Oct 2025 11:02</div> <div>Ref #8.15</div>

8.15	Extractor Hood	Stainless steel extractor hood with control buttons and twin mesh filters; Blue filter frames and black plastic side brackets.	Visible signs of rust and dirt on mesh, cracked plastic bracket, scratched housing and worn areas around fixings.

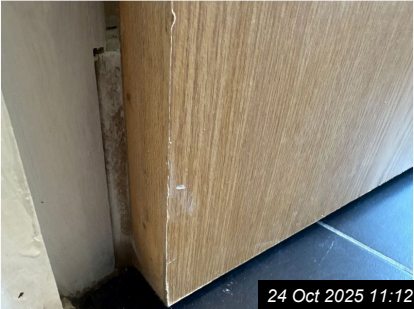
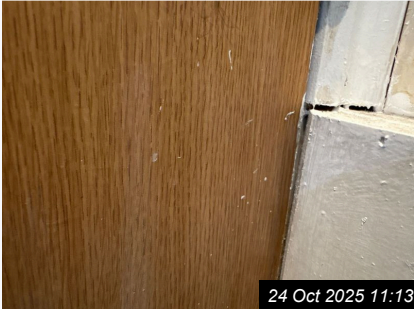
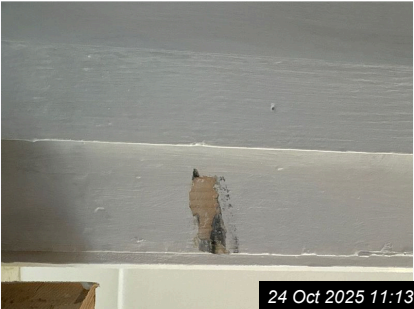
Ref	Name	Description	Condition
9.1	Door & Frame	Wood-effect door with matching frame, golden brown finish, door frame painted white.	Door and frame show multiple areas of minor scratches, chips on edges, paintwork damage, and surface scuffs.

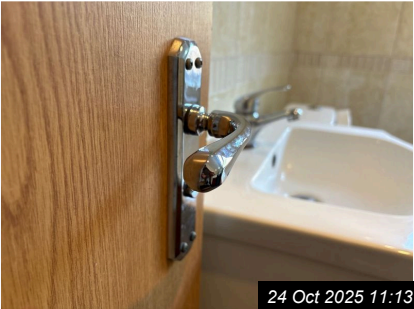
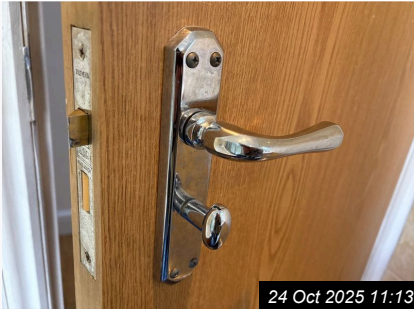
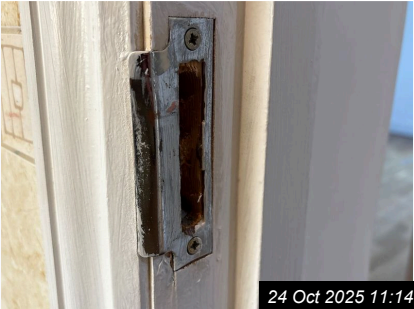
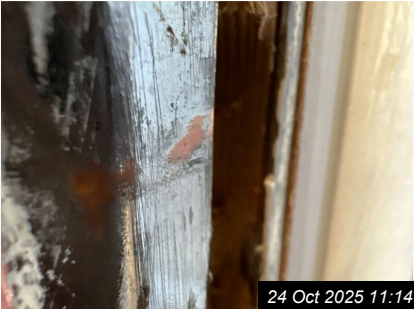
9.2	Door Fixtures	Polished chrome lever handle set and thumb-turn lock	Door handle and thumb-turn show minor surface wear with light scratches; Latch plate is tarnished and displays paint marks

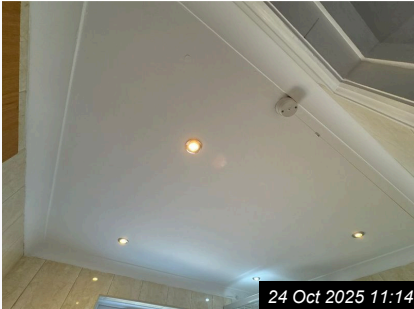
<div>24 Oct 2025 11:14</div><div>Ref #9.3</div></div></div>

9.3	Ceiling	Smooth white plasterboard ceiling	Ceiling appears clean and intact with no visible signs of damp, stains, or cracks.
9.4	Lighting	Ceiling-mounted recessed spotlights with chrome surrounds and integrated LED bulbs.	Multiple units exhibit visible rust and corrosion on the metal surrounds, with no obvious cracks or broken glass, all appear to be in working order

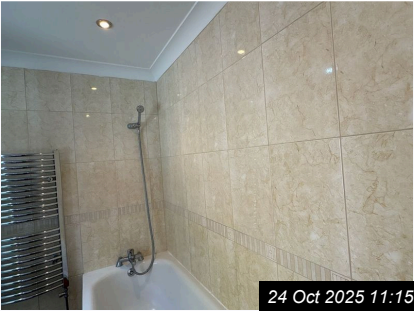
<p>24 Oct 2025 11:15</p> <p>Ref #9.5</p>

9.5	Walls	Large beige marble-effect ceramic tiles	Tiles appear clean with no visible cracks, chips, or stains.
9.6	Skirting	Painted timber skirting board in white	Visible cracks gaps and chipped paint in multiple areas with some surface staining and minor dents present.

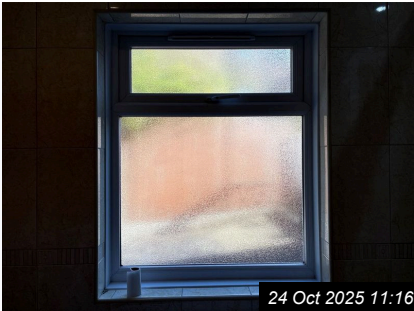
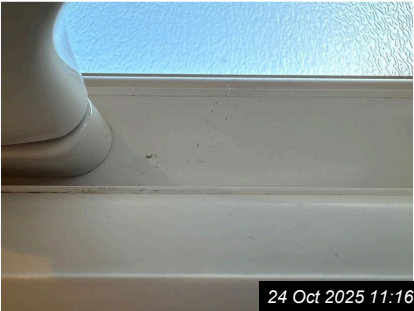
9.7	Windows & Sills	Frosted double-glazed UPVC window in white with matching sill and top vent.	Window and sill are intact with minor surface dirt and marks on the sill; no visible cracks or damage.

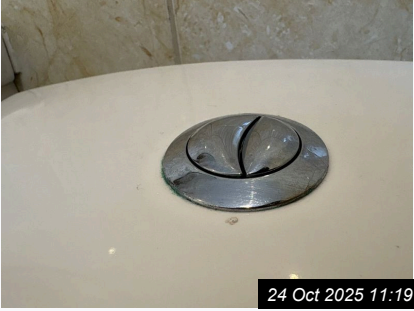
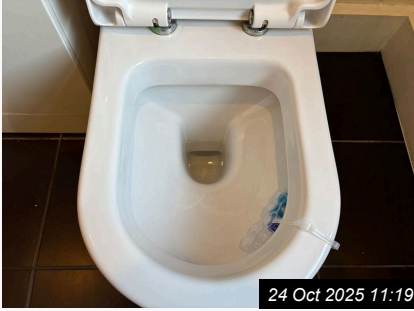
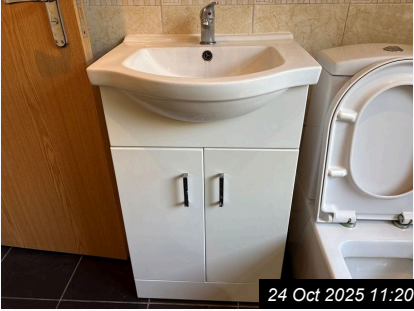
<div>24 Oct 2025 11:19</div> <div>Ref #9.11</div>

9. BATHROOM (CONT.)			
9.11	Toilet	White ceramic close-coupled toilet with dual flush chrome button and standard toilet seat.	Minor limescale and staining visible around flush button and pan, otherwise intact with no visible cracks or damage.

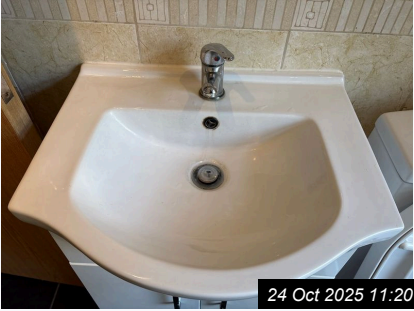
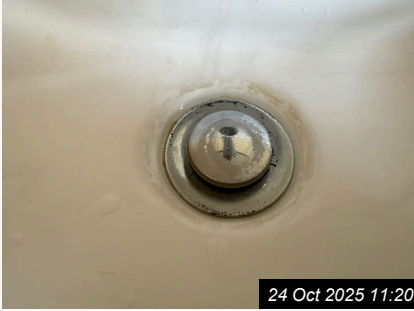
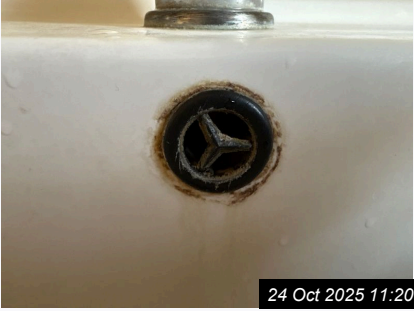
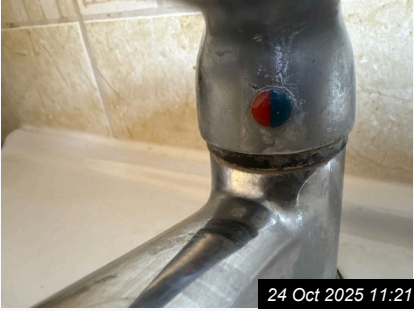
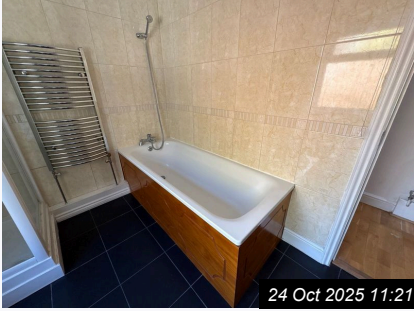
<div>24 Oct 2025 11:20</div> <div>Ref #9.12</div>

9.12	Basin	White ceramic basin with integrated chrome mixer tap, overflow hole, and metal plug on a white cabinet unit.	Visible limescale deposit and rust marks around plug and overflow Pitting and surface wear on tap Overall functional but with signs of use and discolouration.

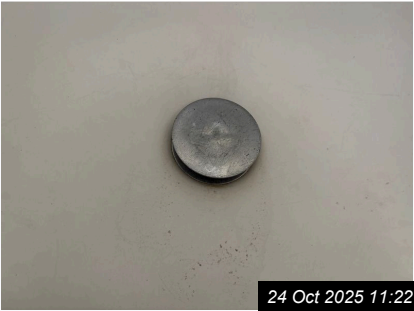
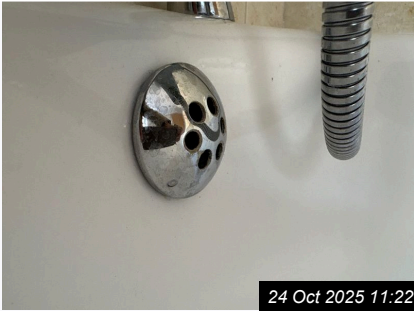
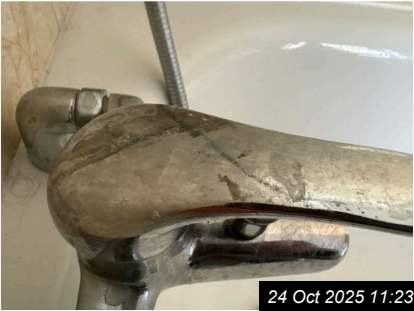
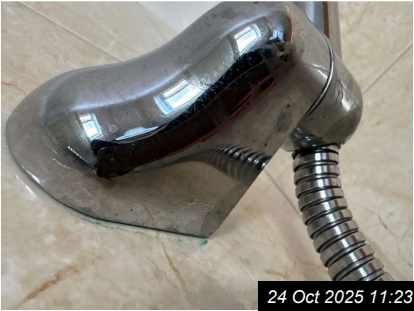
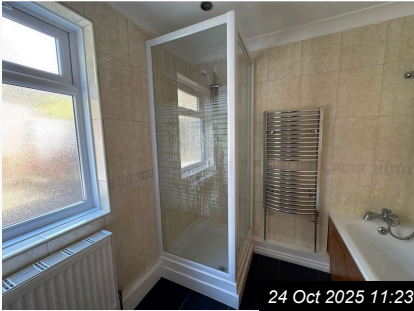
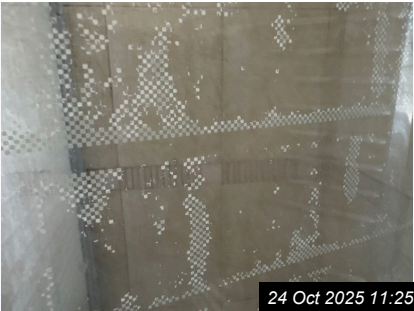
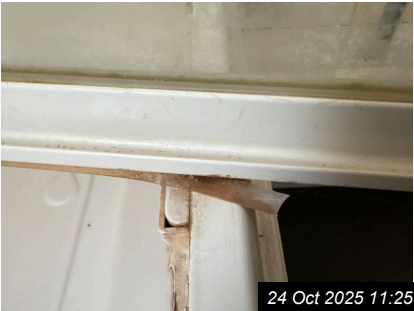
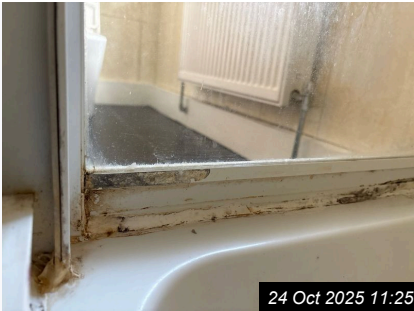
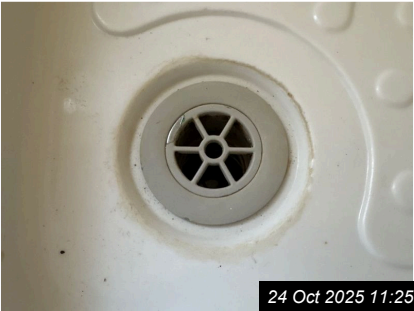
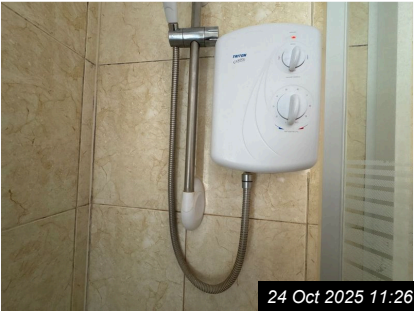
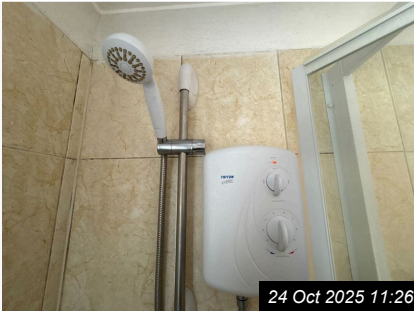
<div>24 Oct 2025 11:21</div> <div>Ref #9.13</div>

9.13	Bath & Taps	White enamel-coated steel bath with wood effect side panel, chrome mixer taps, chrome overflow and plug, handheld shower attachment included.	Bath has light scuffs and minor chips Plug and overflow show light tarnishing Taps have heavy water staining and surface corrosion
Contents

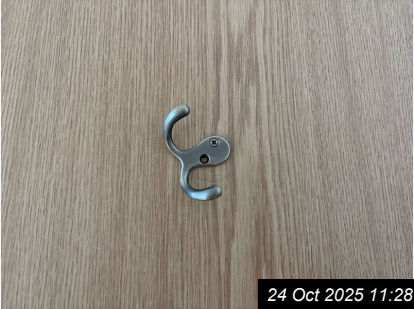
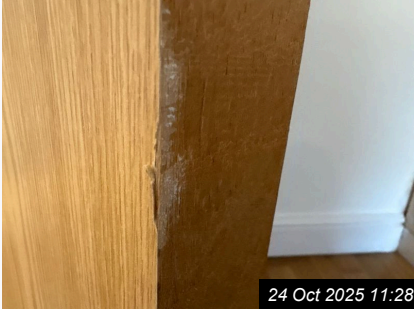
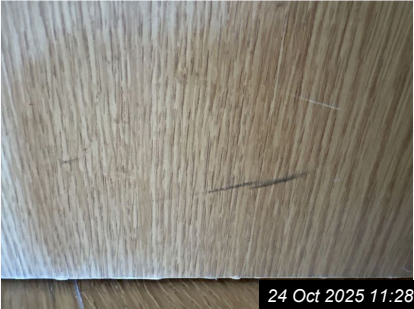
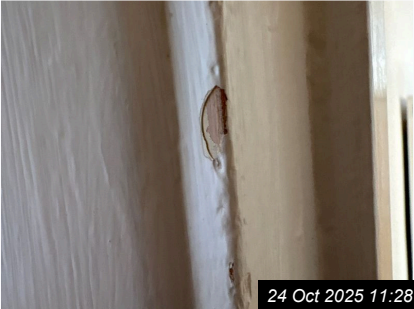
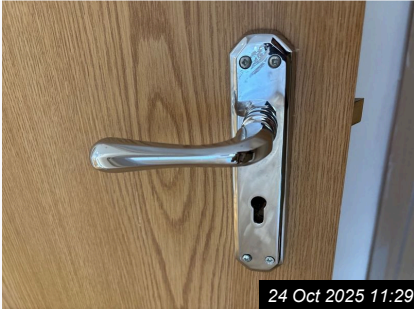
<div>24 Oct 2025 11:28</div><div>Ref #10.1</div></div><div>

Ref	Name	Description	Condition
10.1	Door & Frame	Light oak veneer door with matching wooden frame.	Multiple scratches and scuff marks present on the door Chipped paint and damage on the frame, small dent visible on door surface.

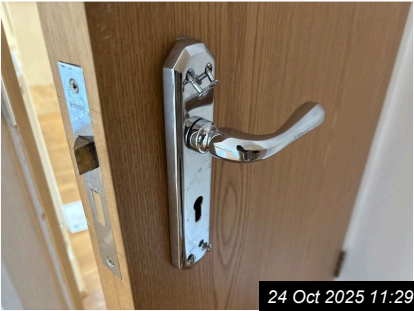
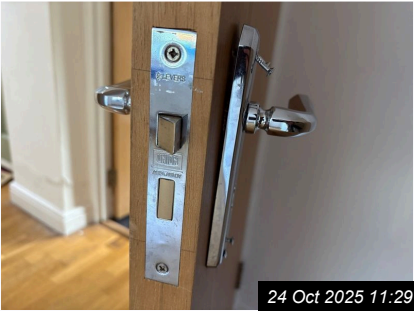
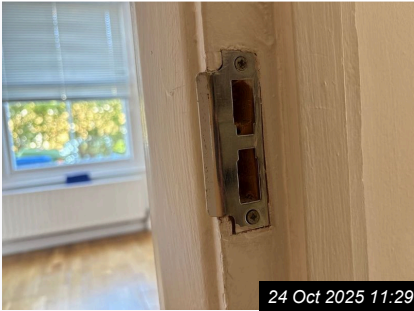
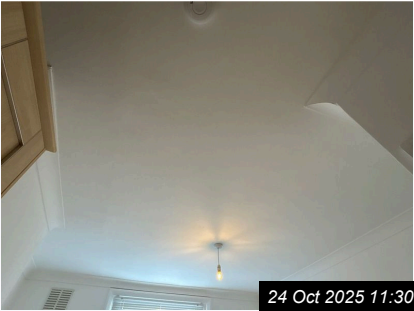
<div>24 Oct 2025 11:29</div><div>Ref #10.2</div></div></div>

10.2	Door Fixtures	Polished chrome lever handle with rectangular backplate Chrome latch and keyhole; Matching chrome strike plate on the frame.	Chrome plates and handles show scratches and scuffs Screws on one handle are misaligned Strike plate and latch show minor wear and paint residue around the edge.

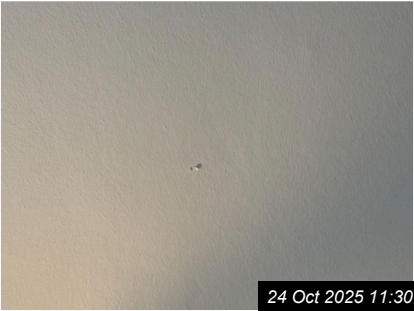
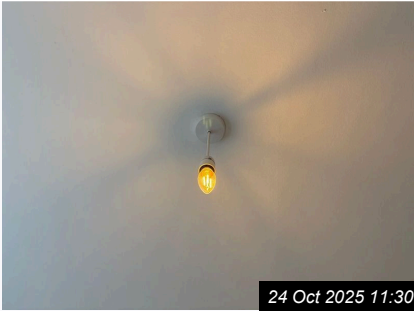
<p>24 Oct 2025 11:30</p> <p>Ref #10.3</p>

10.3	Ceiling	Smooth white painted ceiling	Generally intact with a visible small paint chip or minor damage in one area.
10.4	Lighting	Single exposed bulb light fitting with white ceiling mount and white stem.	Bulb is functional with no visible damage to fitting or mount.

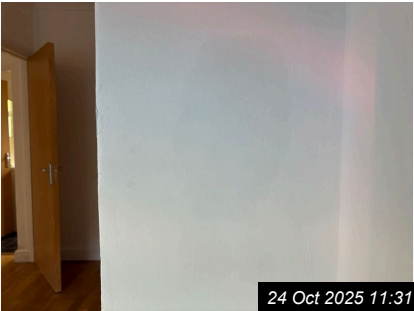
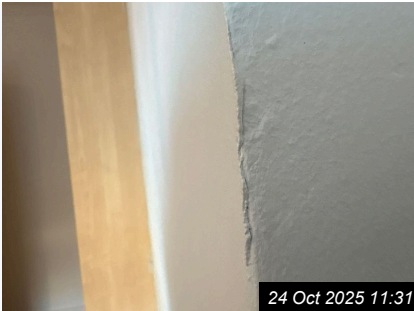
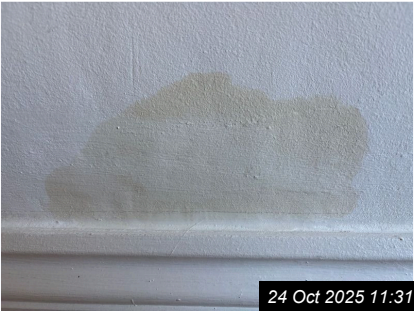
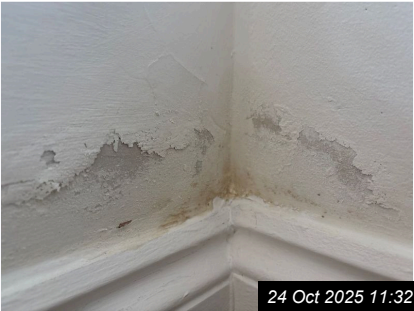
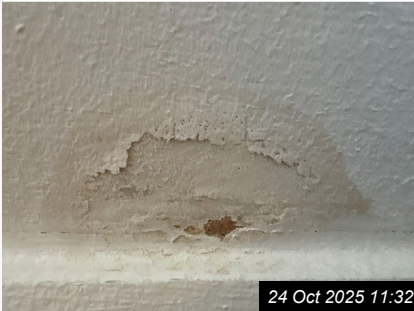
<p>24 Oct 2025 11:31</p> <p>Ref #10.5</p>

10.5	Walls	Painted plaster walls in light off-white colour	Multiple areas of peeling paint, visible cracks, scuff marks, and patches of damp or staining evident at lower sections and corners.

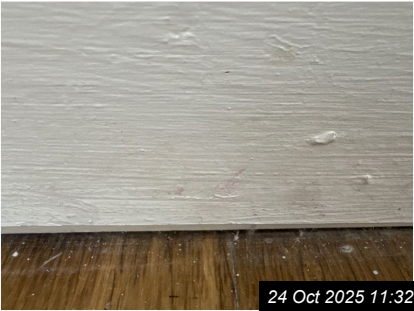
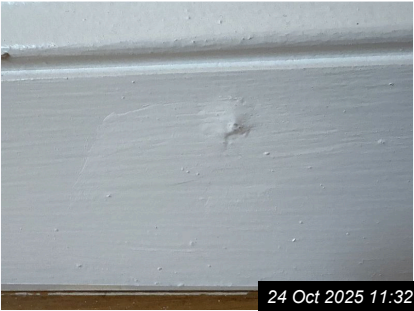
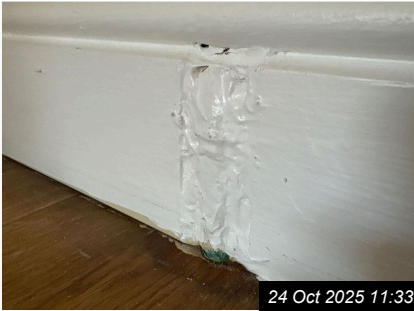
<p>24 Oct 2025 11:32</p> <p>Ref #10.6</p>

10.6	Skirting	White painted timber skirting	Multiple dents, chips, cracks, paint bubbles, surface marks, and poorly executed repair patch visible.

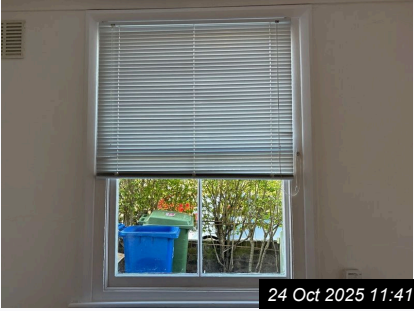
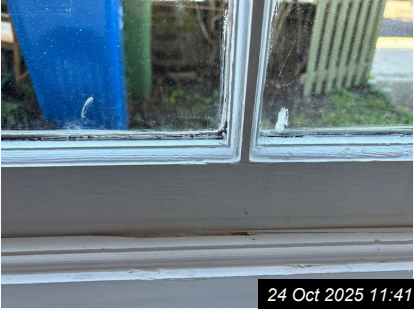
<div>24 Oct 2025 11:41</div> <div>Ref #10.7</div>

10. BEDROOM ONE (CONT.)			
10.7	Windows & Sills	White painted timber window frame with clear glazed panes	Window and sill show signs of minor paint chipping and dirt marks with some wear visible on the lower frame.

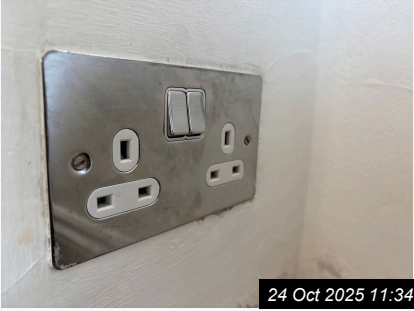
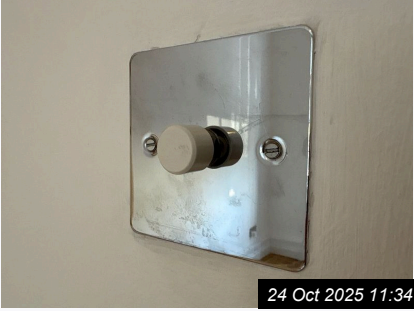
<div>24 Oct 2025 11:34</div> <div>Ref #10.9</div>

10.9	Switch / Sockets	Double socket outlet with switches White plastic dimmer switch with chrome faceplate	Minor surface scratches and tarnishing visible signs of wear but no visible cracks or breaks

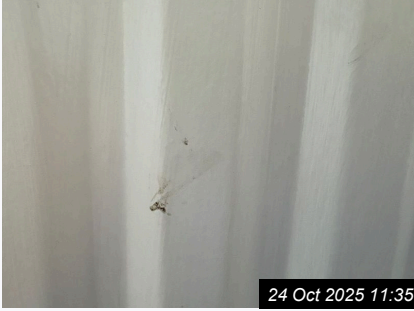
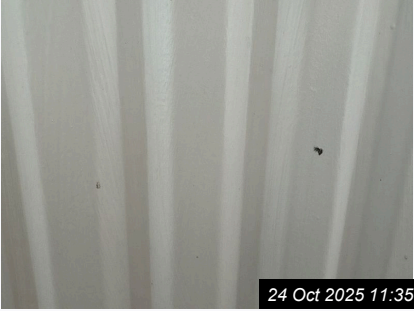
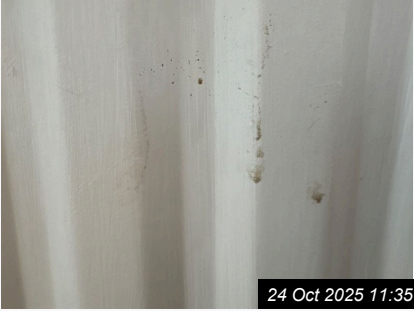
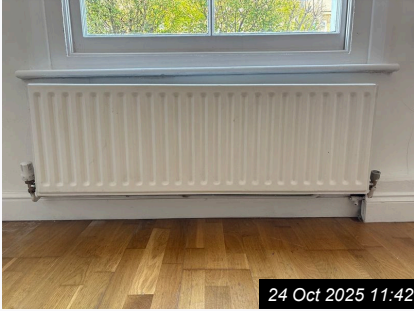
<div>24 Oct 2025 11:35</div> <div>Ref #10.10</div>

10.10	Heating	Wall-mounted white metal panel radiator	Multiple marks and minor stains on the surface with visible signs of dirt and some scuffs but no obvious structural damage.

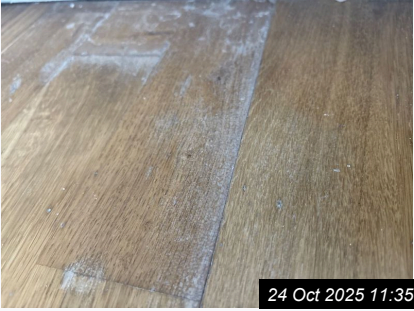
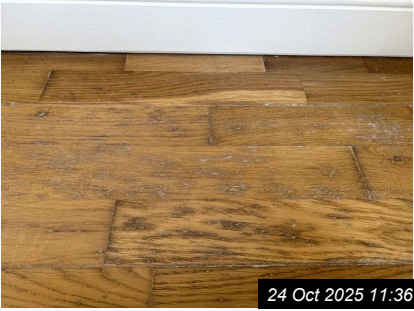
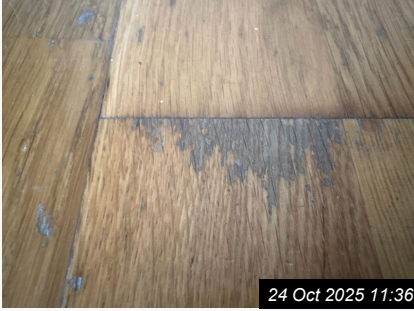
<div>24 Oct 2025 11:35</div> <div>Ref #10.11</div>

10.11	Flooring	Wooden plank flooring with medium brown finish and natural grain patterns.	Scuffed surface with visible scratches, dust, and patches of worn or peeling finish.
