# Inventory & Check In

**WILSON**  
INVENTORIES

Example  
Inventory  
Report

**October**  
**25th 2025**  
10:00

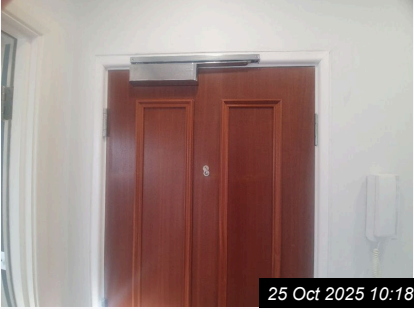
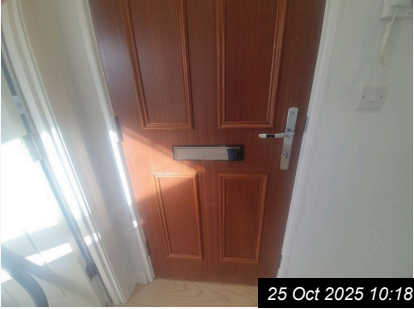
<p>25 Oct 2025 10:18</p> <p>Ref #6.1</p>

Ref	Name	Description	Condition
6.1	Door & Frame	Solid wood door with a natural brown finish White painted frame.	Door and frame appear clean and well-maintained with no visible damage or significant signs of wear.

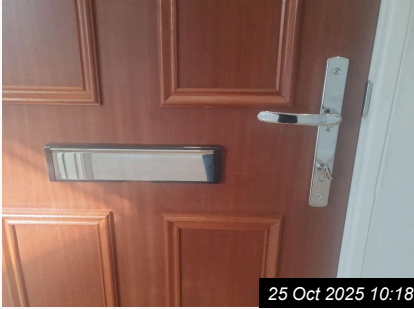
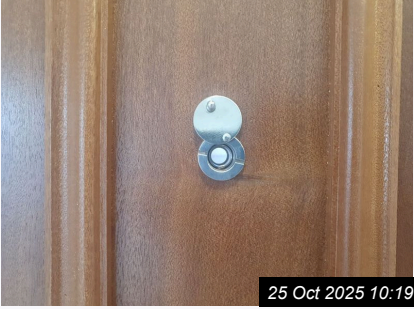
<p>25 Oct 2025 10:18</p> <p>Ref #6.2</p>

6.2	Door Fixtures	Polished chrome letterbox, handle, lock, and peephole	All fixtures appear free from visible damage and show minimal signs of wear.
6.3	Ceiling	Smooth white painted ceiling	No visible damage or marks, ceiling appears clean and intact.

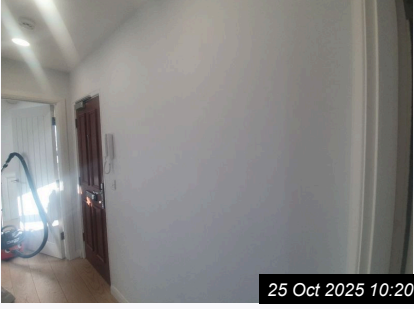
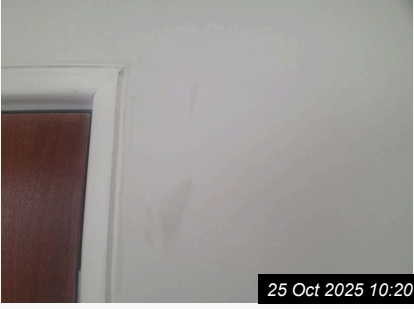
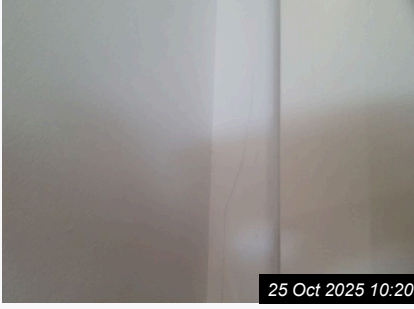
<p>25 Oct 2025 10:20</p> <p>Ref #6.5</p>

6.4	Lighting	Two recessed ceiling spotlights with white trim fitted	Both lights are working with no visible signs of damage or wear.
6.5	Walls	Painted plaster walls in a light colour	Light marks and scuffs near the door frame and a visible fine crack in the corner, otherwise generally well-maintained.

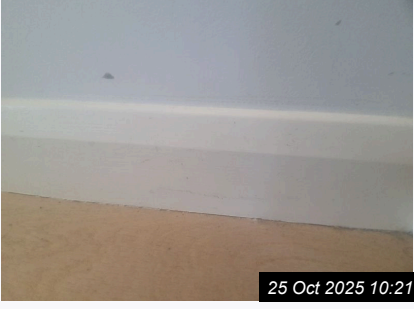
<p>25 Oct 2025 10:21</p> <p>Ref #6.6</p>

6.6	Skirting	White painted wooden skirting board	Shows minor scuff marks and light surface dirt with a small patch of paint damage.
6.7	Switch / Sockets	One white plastic light switch One white plastic dual socket with individual switches All flush-mounted to the wall.	No visible damage or wear, sockets and switches appear clean and intact.

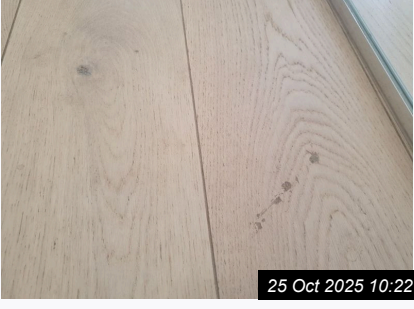
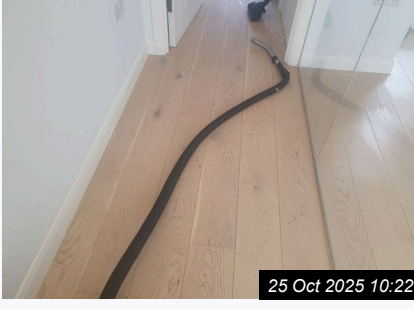
<p>25 Oct 2025 10:22</p> <p>Ref #6.8</p>

6.8	Flooring	Light natural wood plank flooring with visible wood grain and knots	Some minor scuffs and marks present with light general wear visible
Contents

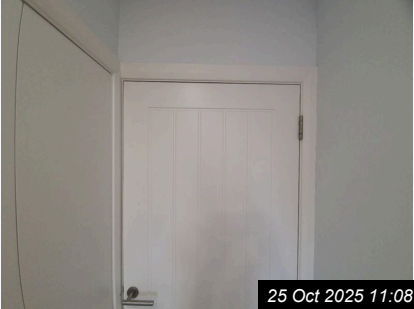
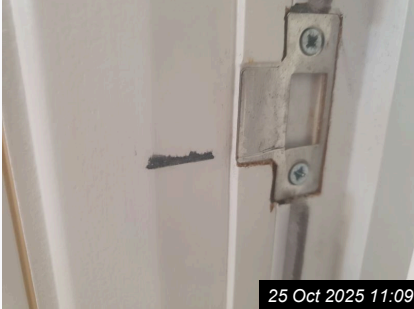
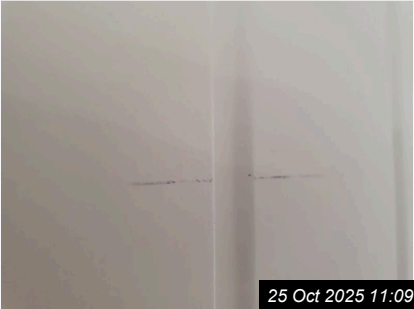
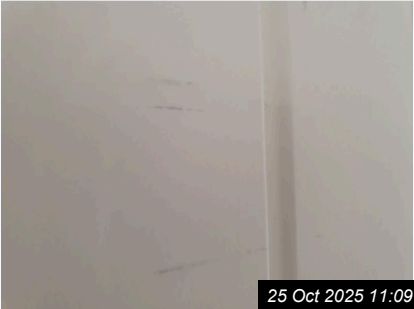
<div>25 Oct 2025 11:08</div><div>Ref #7.1</div></div><div>

Ref	Name	Description	Condition
7.1	Door & Frame	White painted wooden door and frame	Several black scuff marks and minor scratches are present on the door and frame near the latch area.

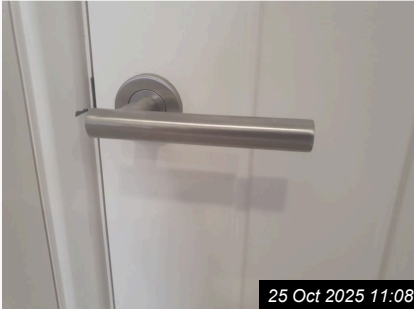
<div>25 Oct 2025 11:08</div><div>Ref #7.2</div></div></div>

7.2	Door Fixtures	Brushed metal cylindrical lever handle Matching brushed metal door hinge	Handle is clean with minor paint transfer near base hinge has slight paint residue and minor scuffs.

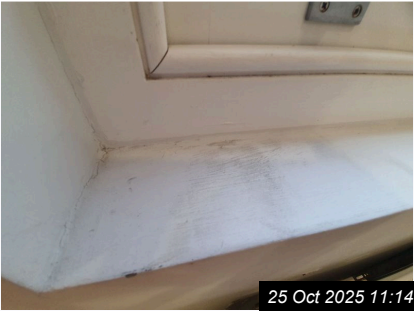
Ref #7.7

7. BEDROOM ONE (CONT.)			
7.7	Windows & Sills	White painted timber sash windows with metal latch hardware and matching timber sills.	Minor scuff marks and dirt present on sills, paint worn in areas, window locks appear functional.

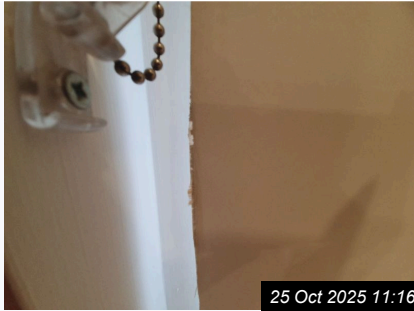
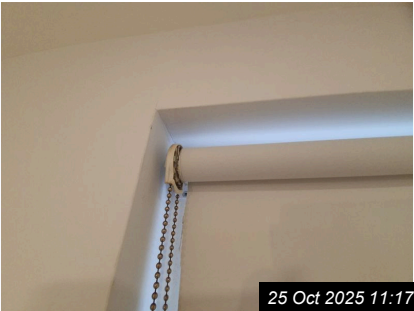
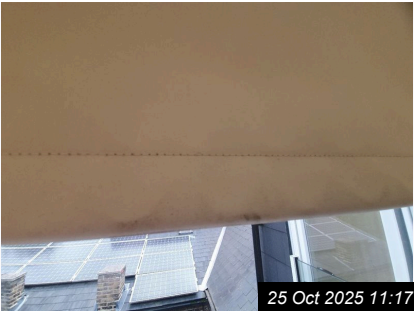
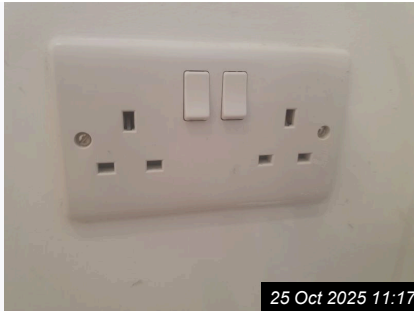
Ref #7.8

7.8	Blinds / Curtains	White fabric roller blind with bead chain mechanism fitted inside window recess.	Blind has visible marks and dirt near the bottom edge, wear on the roller mechanism and recess paint, minor chipping on window frame.

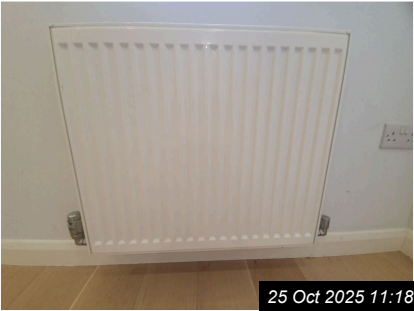
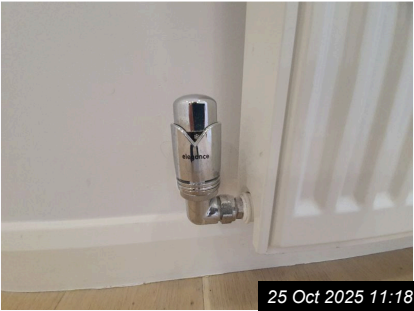
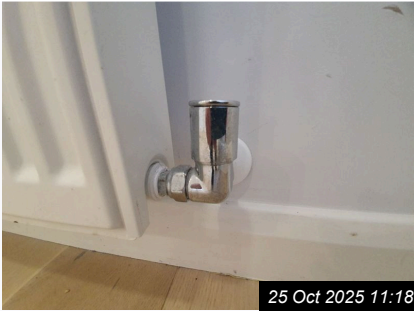
Ref #7.10

7.10	Heating	White metal panel radiator with chrome thermostatic and lockshield valves fitted at each end.	Radiator and valves are clean with no visible rust or damage, very minor scuff marks to wall nearby.

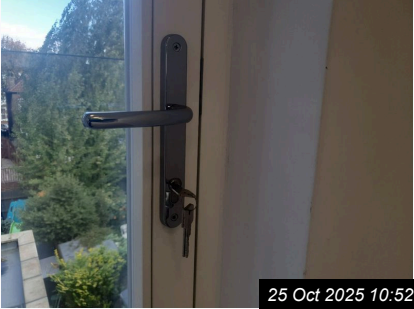
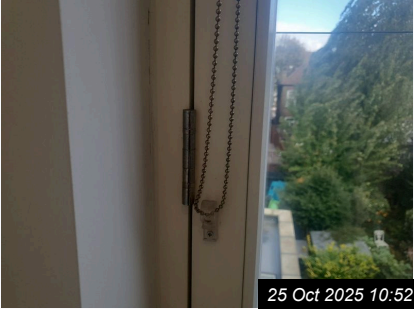
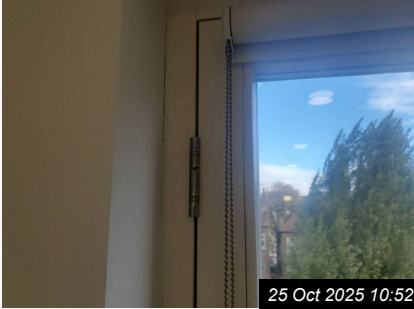
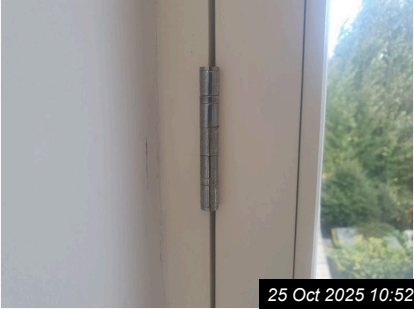
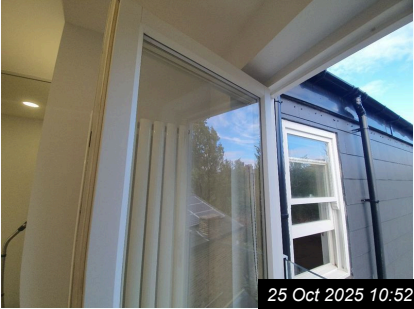
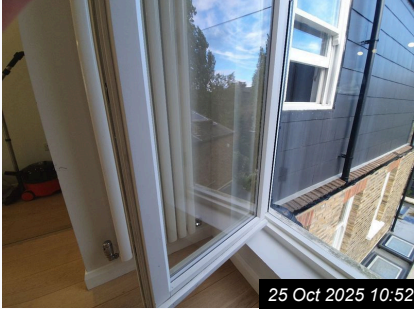
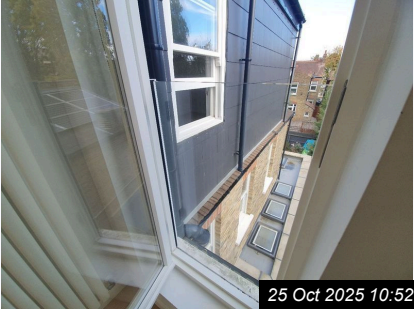
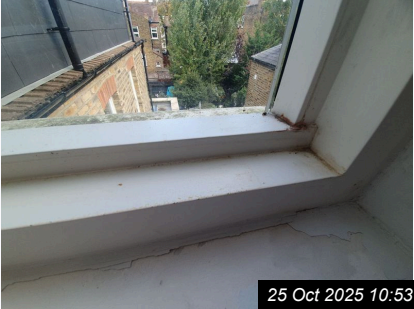
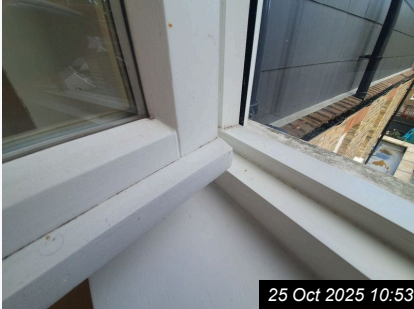
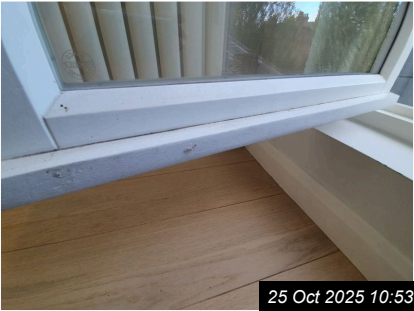
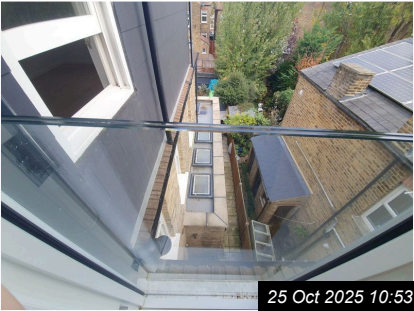
<div>25 Oct 2025 10:52</div><div>Ref #8.2</div></div><div>

Ref	Name	Description	Condition
8.1	Door & Frame	White painted wooden door with fitted glass panels	Appears in good condition
8.2	Door Fixtures	Silver metal lever handle with matching lock mechanism and keys Three silver metal hinges, and a chain restrictor fitted	Handle and hinges show minimal wear, chain restrictor intact, timber frame and sill have visible chips, scratches, dirt, and some patches of rust present at the base.

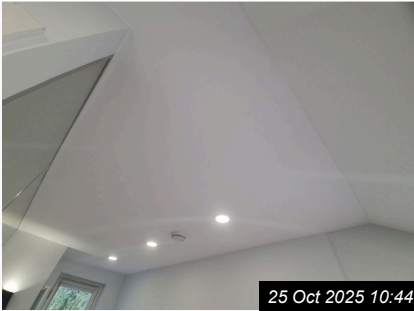
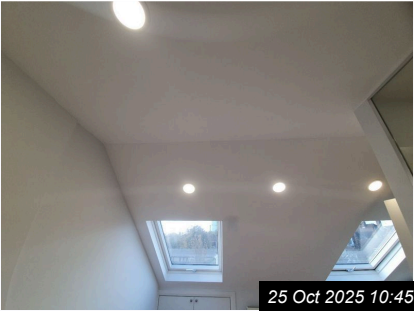
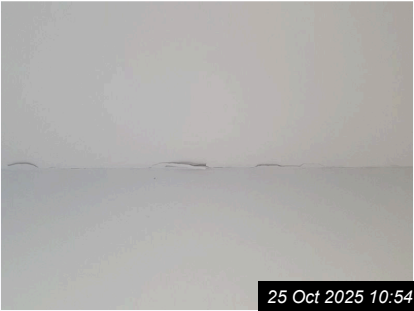
<div>25 Oct 2025 10:44</div> <div>Ref #8.3</div>

8.3	Ceiling	White painted plaster ceiling with skylight openings.	Ceiling has visible cracks and peeling paint along joint lines.
8.4	Lighting	Recessed ceiling downlights in white and a black rectangular wall sconce with upward and downward light projection.	All lights are operational with no visible damage or signs of wear.

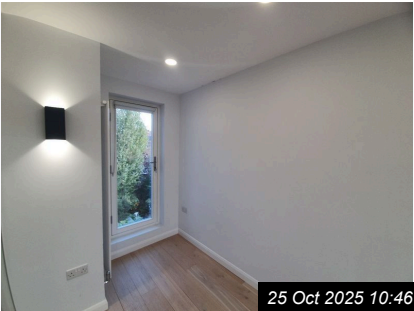
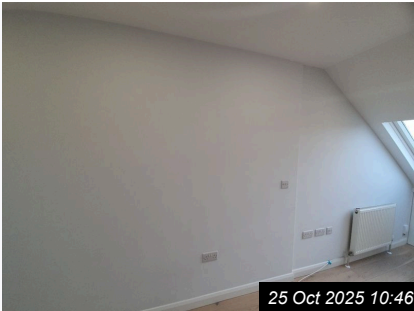
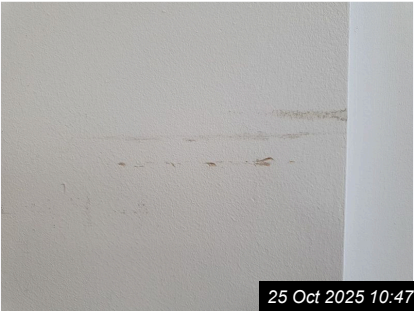
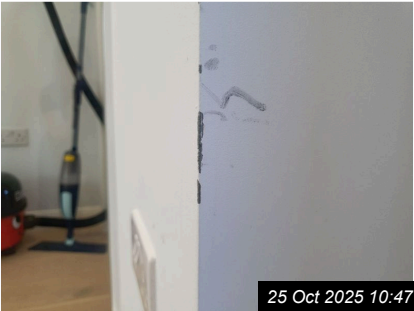
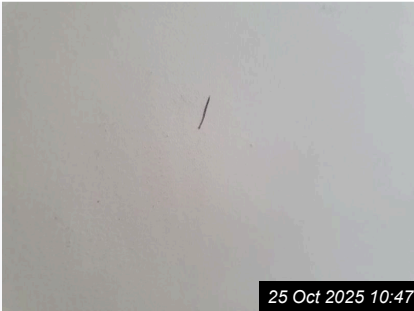
8.5	Walls	Walls are plastered, painted white	Walls display multiple scuff marks, scratches, paint chips, and minor surface damage.
8.6	Skirting	White painted wooden skirting board	Minor scuff marks and a small chip present, otherwise generally intact.

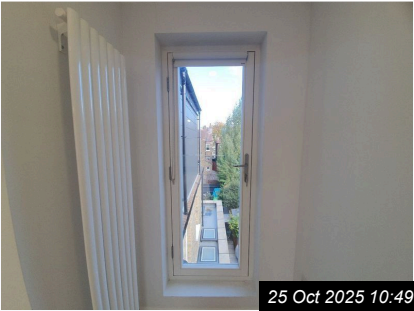
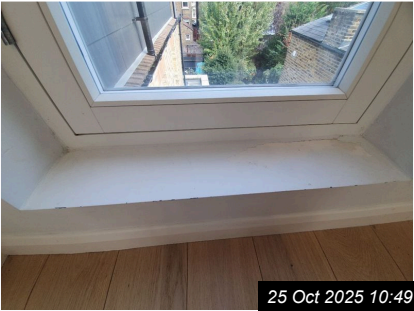
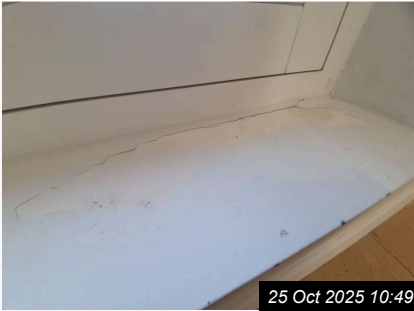
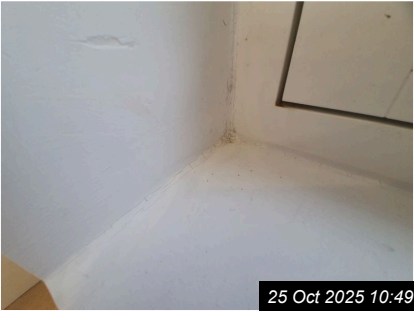
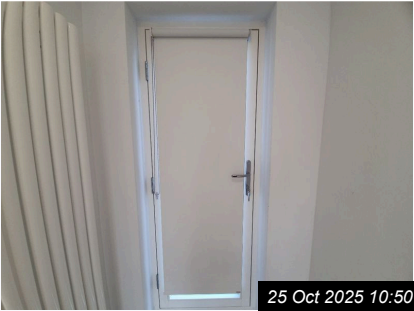
8.7	Windows & Sills	Tall double glazed window with white uPVC frame and painted timber sill.	Window frame is in good condition but sill shows surface cracks, minor paint damage, and some discolouration in corners.

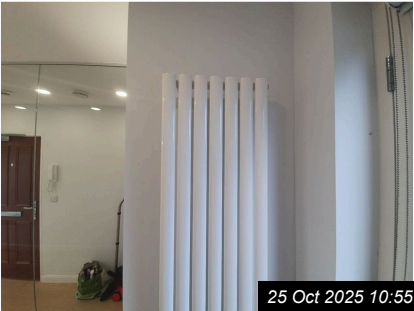
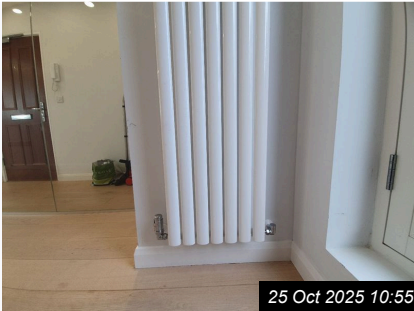
8.10	Heating	Vertical white tubular steel radiator with chrome thermostatic and manual valves	Radiator and valves show minor surface marks and light soiling on lower pipes, wall around the installation has visible hairline cracks.

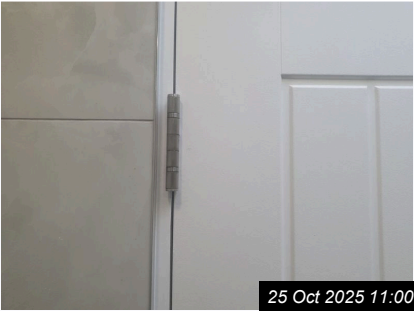
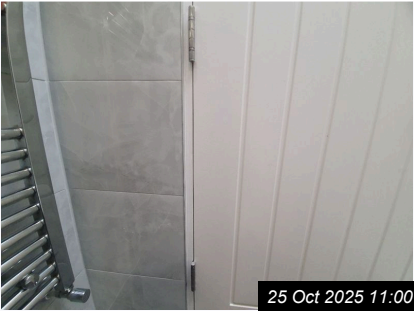
<div>25 Oct 2025 11:00</div> <div>Ref #9.2</div>

9.2	Door Fixtures	Brushed metal lever handle with integrated privacy lock and matching metal hinges	Handle, lock and hinges are clean and free of visible damage or corrosion, with no significant signs of wear.

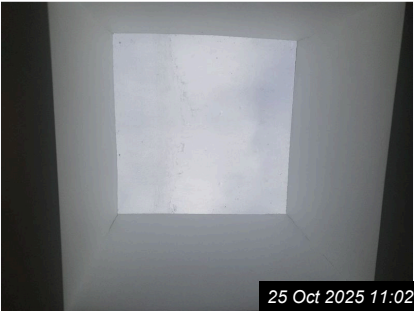
<div>25 Oct 2025 11:02</div> <div>Ref #9.7</div>

9.7	Windows & Sills	Frosted glass skylight window with white painted sills.	Minor discolouration visible on glass and light marking on sills, otherwise intact.

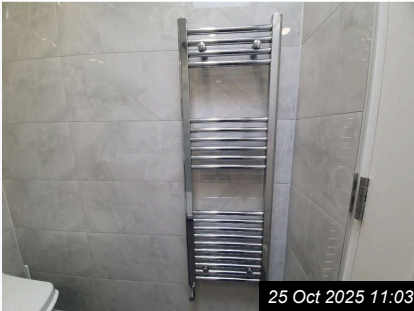
<div>25 Oct 2025 11:03</div> <div>Ref #9.9</div>

9.9	Heating	Chrome-finished wall-mounted towel rail radiator with multiple horizontal bars.	Multiple small rust patches and signs of corrosion present on joints and connecting bars, with some discolouration visible near pipe connections and mounting points.

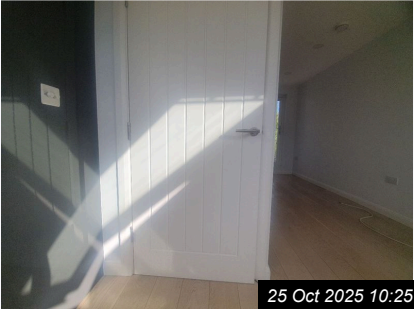
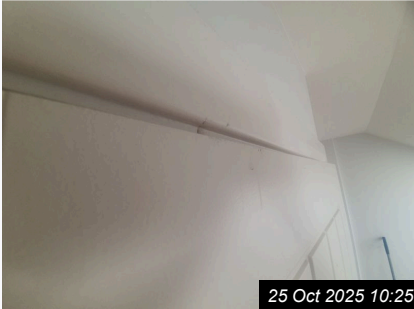
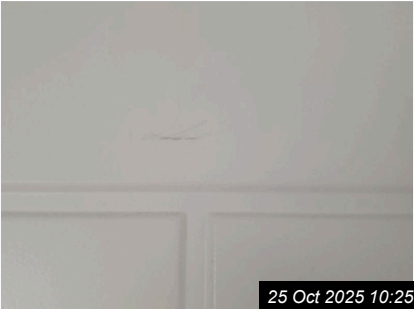
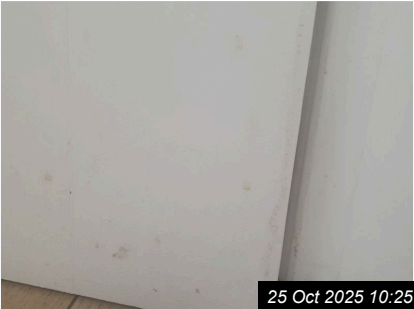
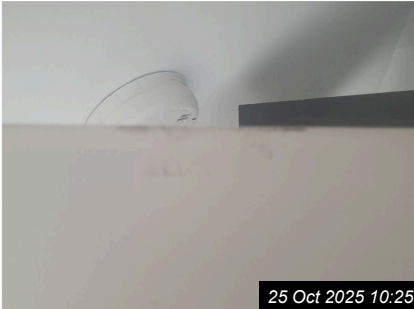
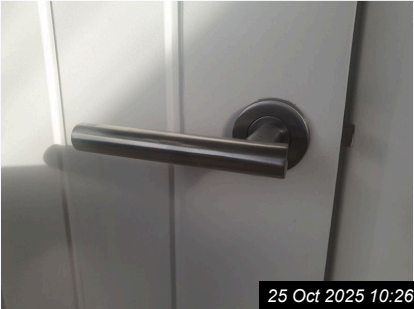
<div>25 Oct 2025 10:25</div><div>Ref #10.1</div></div><div>

Ref	Name	Description	Condition
10.1	Door & Frame	White painted timber door with vertical grooves and matching white frame	Door has visible scuff marks, scratches, and some dirt marks, especially on the lower section and edges; Frame is generally intact with minor surface marks.

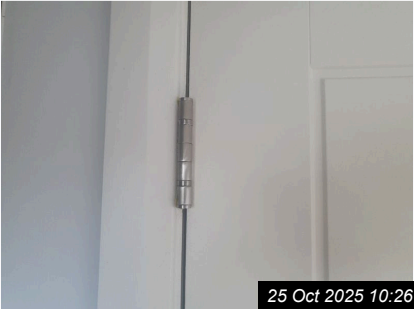
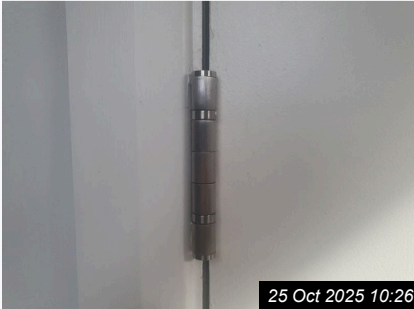
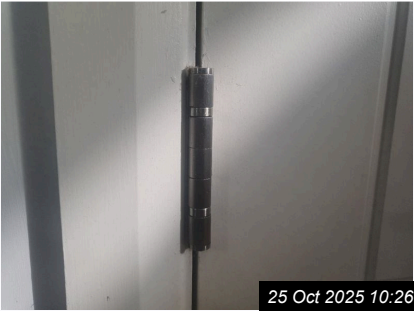
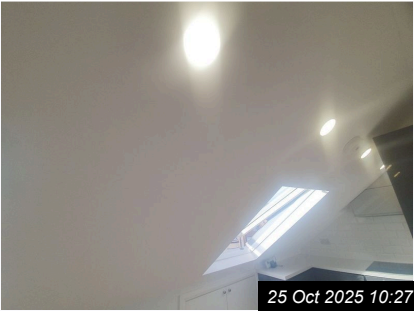
<div>25 Oct 2025 10:26</div><div>Ref #10.2</div></div><div>

10.2	Door Fixtures	Brushed metal lever handle and cylindrical metal hinges installed on a white painted door.	All fixtures show minimal wear with slight scuff marks visible near some hinges; All are securely fitted and in good working order.

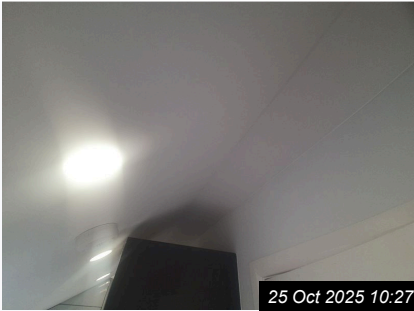
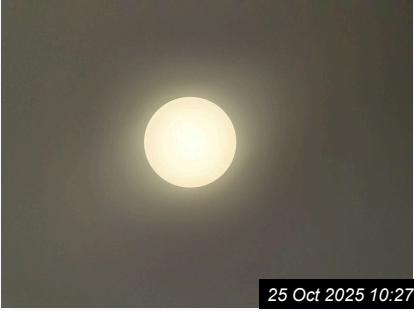
<p>25 Oct 2025 10:27</p> <p>Ref #10.3</p>

10.3	Ceiling	White painted plasterboard ceiling	Ceiling appears clean and intact with no visible signs of damage or staining.
10.4	Lighting	Ceiling-mounted recessed circular downlights with frosted white covers.	Lights are functioning with no visible damage or signs of wear.

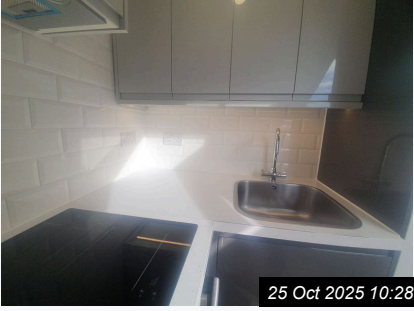
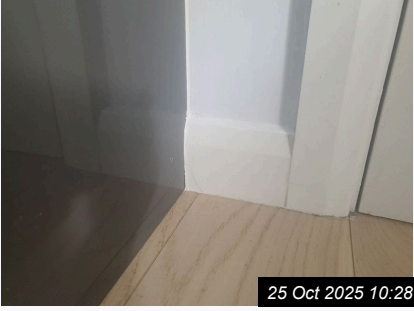
<p>25 Oct 2025 10:28</p> <p>Ref #10.5</p>

10.5	Walls	Gloss white rectangular ceramic tiles arranged in a brick pattern	No visible damage or marks, grout and tiles appear intact and clean.
10.6	Skirting	White painted wooden skirting	Skirting is generally clean with minor scuff marks and light discolouration in some areas, no significant damage observed.

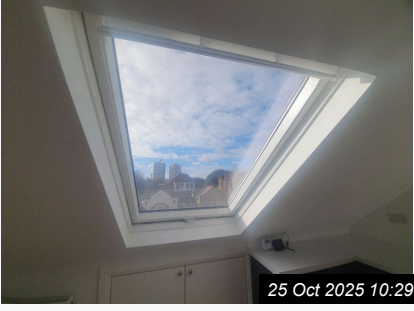
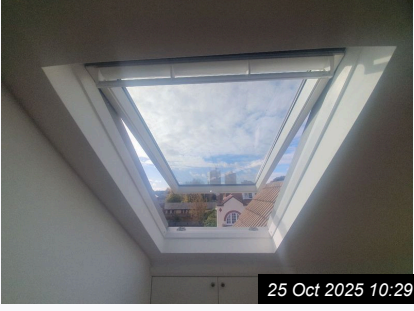
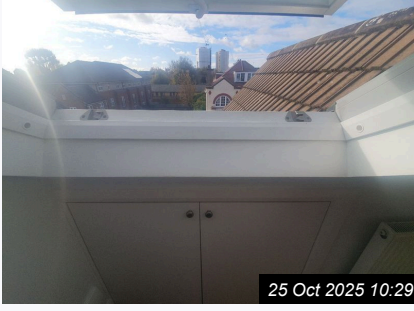
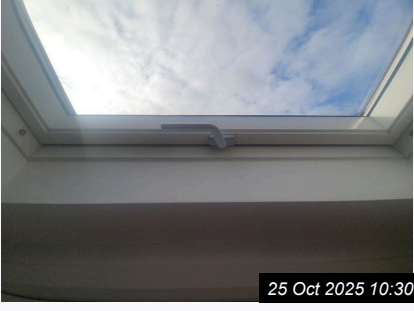
10. KITCHEN (CONT.)			
10.7	Windows & Sills	Large double-glazed skylight window with white uPVC frame and integrated white sill.	Window and sill are clean with no visible damage or signs of wear.

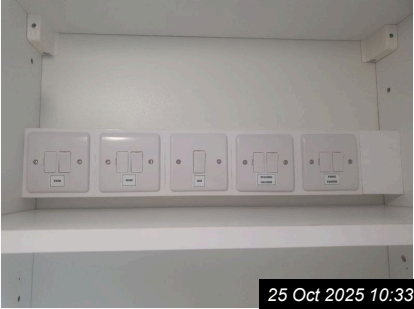
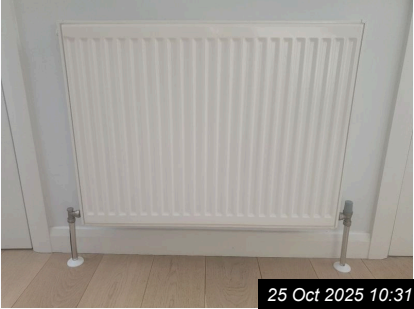
10.9	Heating	White metal panel radiators with vertical grooves mounted to the wall, fitted with standard pipework and control valves.	Radiators and valves appear clean with no visible dents, scratches, or signs of leakage.

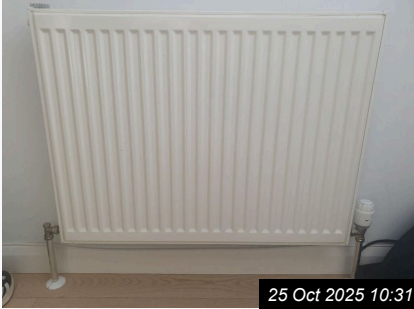
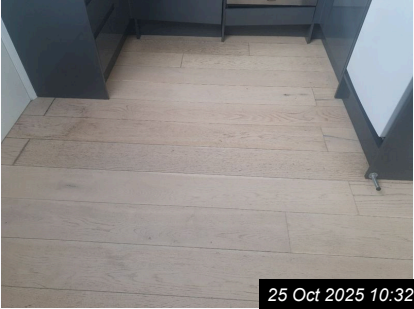
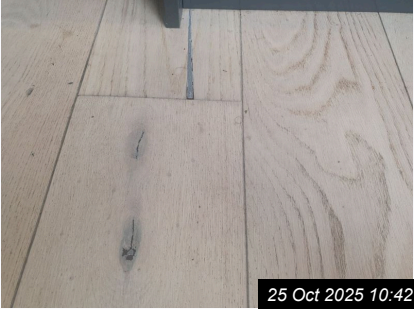
10.10	Flooring	Light wood plank flooring with visible natural grain and knots.	Multiple visible gaps between planks, cracks, and signs of wear throughout the flooring.

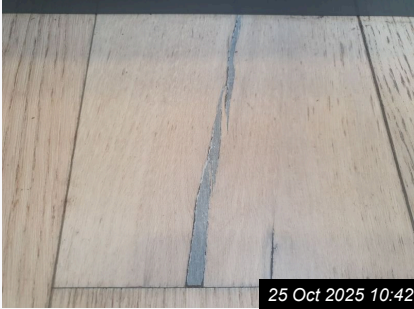
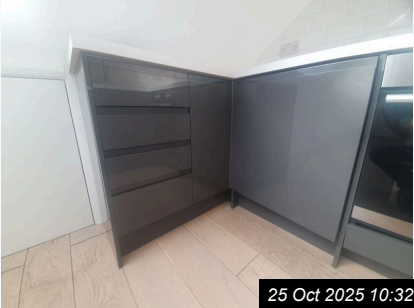
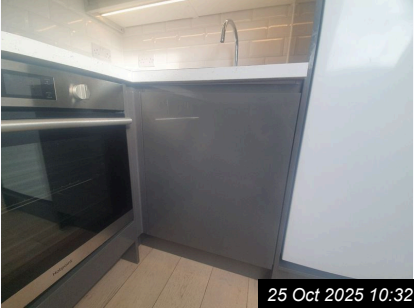
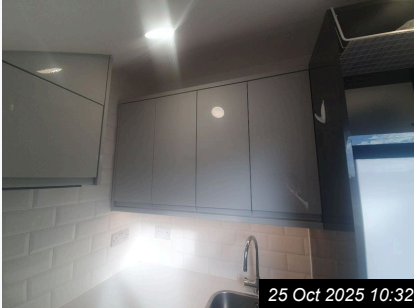
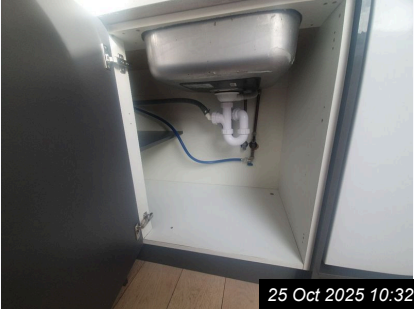
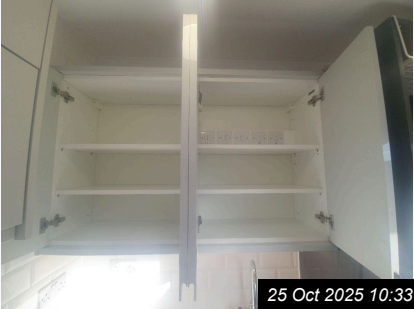
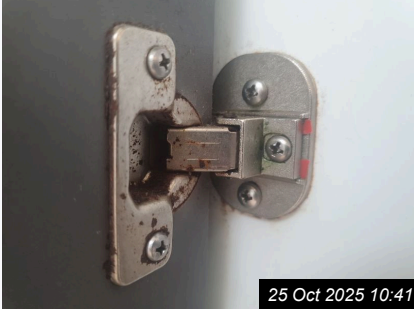
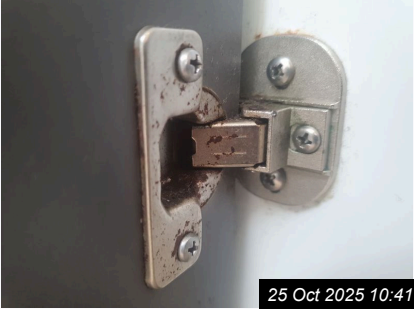
10.11	Kitchen Units	Glossy dark grey handleless kitchen units with matching drawers and doors Wall and base cupboards Laminate interiors and integrated fittings.	Unit hinges are rusted, some general dirt is present, lower plinth is loose or detached, internal shelves and cupboard areas have minor wear but no significant visible damage. <a href="#">Review - Investigate</a>

Actions Required			
Ref	Action Required	Responsibility	Comments
<a href="#">10.11</a> KITCHEN » Kitchen Units	Review	Investigate	Unit hinges are rusted, some general dirt is present, lower plinth is loose or detached, internal shelves and cupboard areas have minor wear but no significant visible damage.;
<a href="#">10.19</a> KITCHEN » Washing Machine	Review	Investigate	Some visible dirt and mould present on the inner door seal, no obvious structural damage observed.

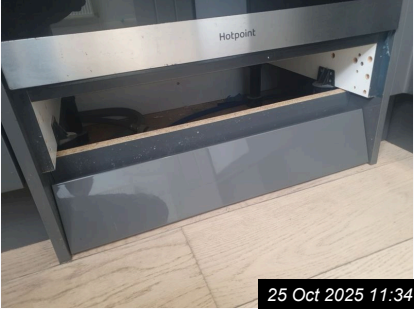
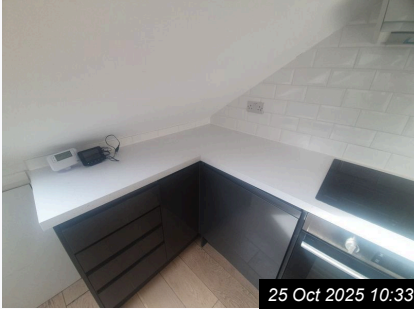
10.12	Worktops	White solid surface worktops with smooth finish Integrated stainless steel sink, and provision for appliances.	Worktops show no visible marks, stains, or damage, edges and surfaces appear intact throughout.

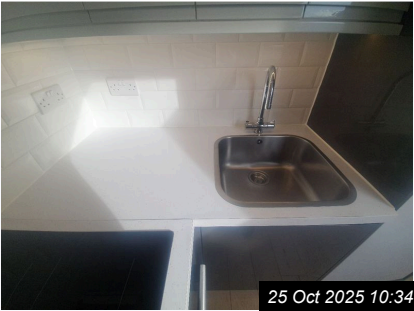
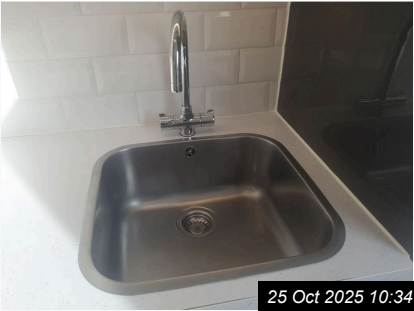
10.13	Sink	Stainless steel single bowl sink with chrome mixer tap	Sink, tap and surrounding worktop are clean with no visible signs of wear, damage, or staining.

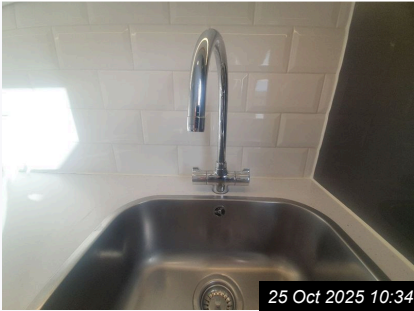
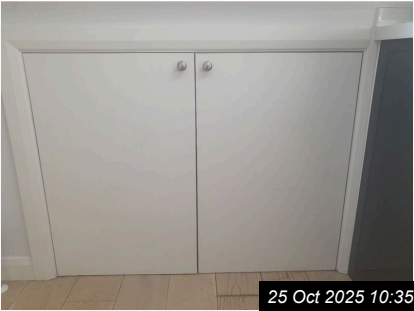
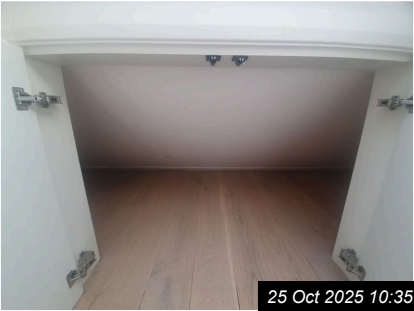
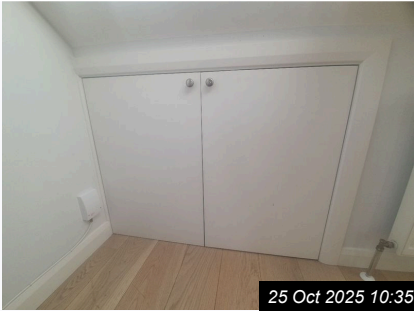
10.14	Built-In-Storage	White built-in storage unit with two hinged doors and metal knobs, featuring internal shelf-less space and sloped back wall, constructed of wood or MDF.	Doors and hinges intact with no visible damage, interior and exterior show minor surface marks and light scuffs.
Appliances

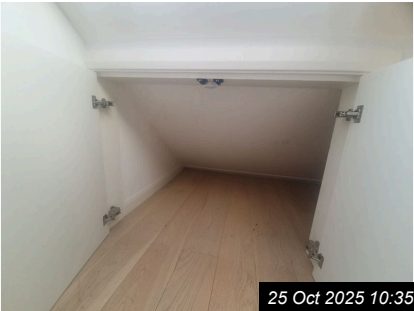
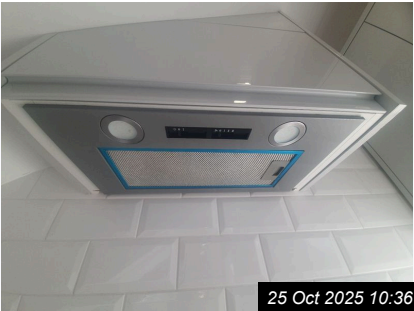
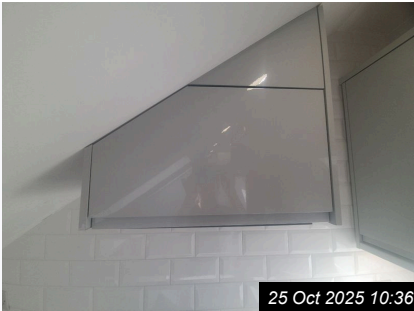
10.15	Extractor Hood	Stainless steel extractor hood with integrated lighting, mesh filter, and control switches, fitted into an angled gloss cabinet.	Extractor hood appears undamaged and clean with no visible signs of wear or damage; fittings and ducting inside cabinet are intact.

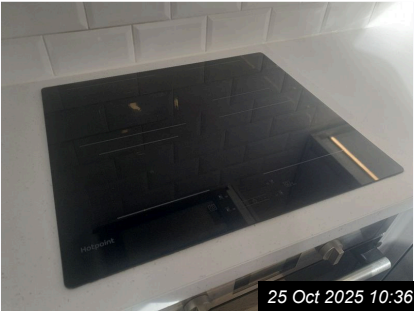
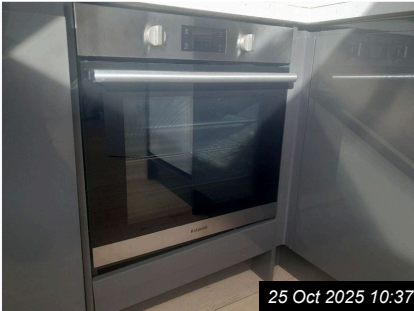
10.17	Oven	Integrated stainless steel oven with digital display, two control knobs, and three internal trays including racks and a baking tray.	Oven exterior and interior appear clean with minor signs of use visible on trays and racks, no visible damage or heavy wear.

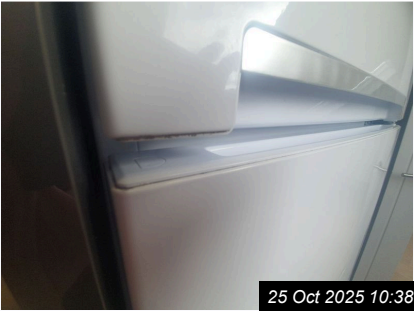
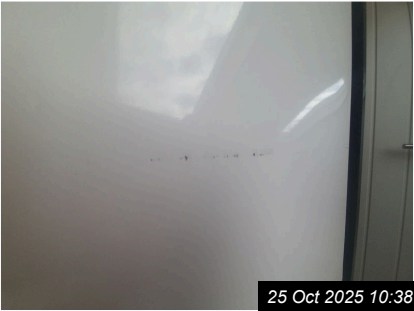
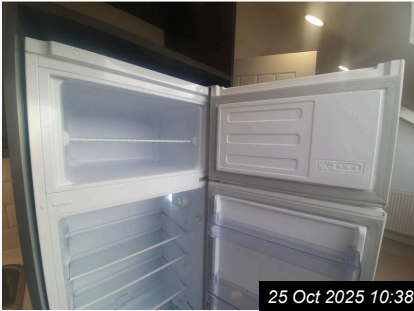
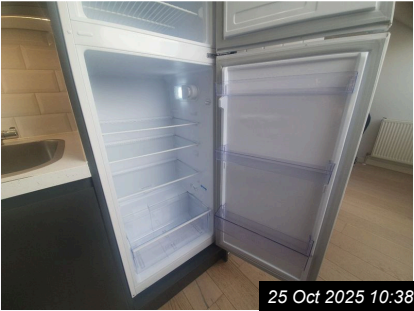
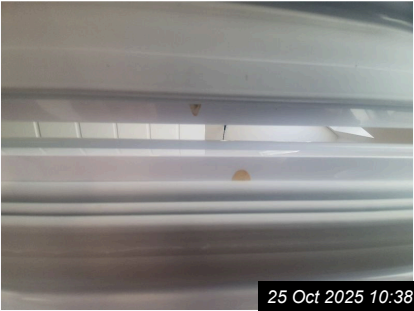
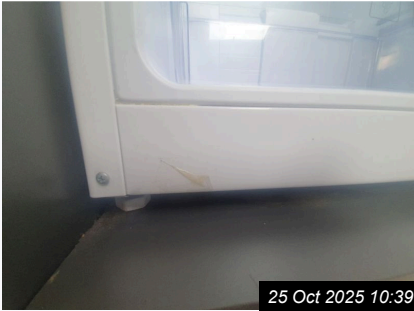
10.18	Fridge / Freezer	Freestanding white Beko fridge freezer with a top freezer compartment Matching metal handles, and multiple door storage racks and shelves inside.	Small areas of rust on the door, scuffs and marks to the outside, some internal shelf stains, and a cracked area near the bottom.

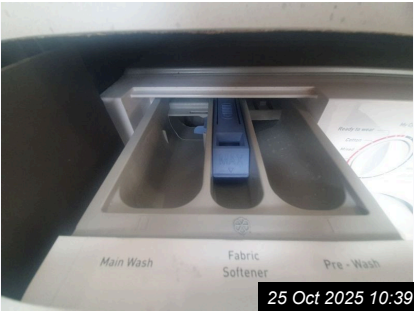
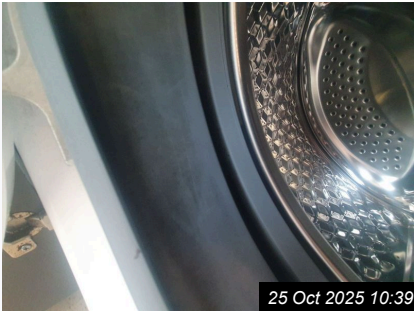
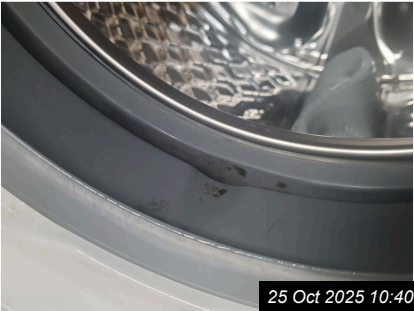
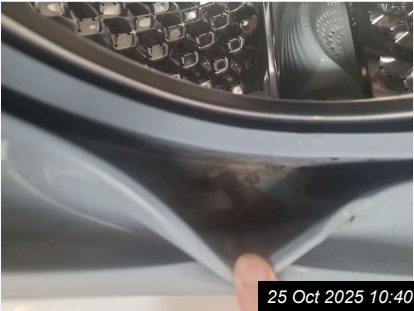
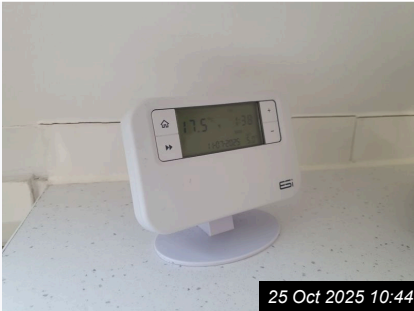
Ref #10.19

10. KITCHEN (CONT.)			
10.19	Washing Machine	Built-in white front-loading washing machine with digital controls Stainless steel drum and transparent door.	Some visible dirt and mould present on the inner door seal, no obvious structural damage observed. <div>Review - Investigate</div>
Contents

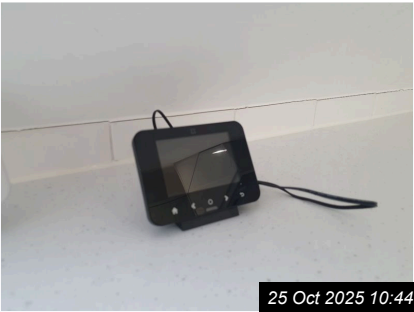
Ref #10.20

10.20	Thermostat	White digital thermostat with LCD display and navigation buttons on a circular base, positioned on a kitchen worktop.	Thermostat is clean with no visible damage or significant wear.
